Cambria Community Healthcare District
2535 Main Street, Cambria, CA

Facility Condition Assessment & Report

**Orry Nottingham PE CAP Inc.
Commissioning Authority & Professional Engineer
November 8, 2021**

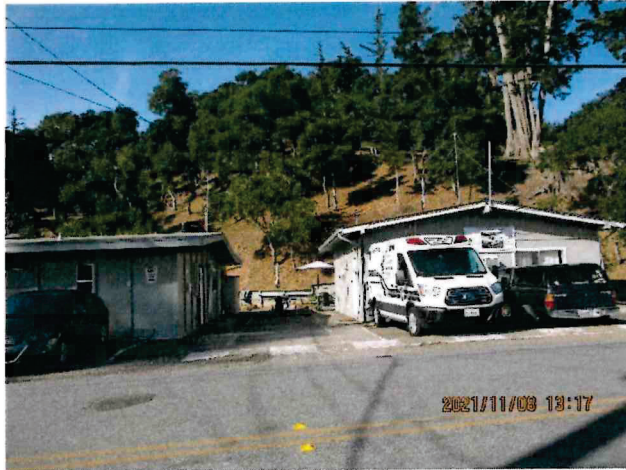
Photo 1. View from Main Street Vehicle Garage Photo 2. View from Main Street to Operations

As you can see in above Photo 1. View from Main Street Vehicle Garage building, a rather steep hill can be seen in the photo (upper left NW corner) which is above the condemned Vehicle Garage building.

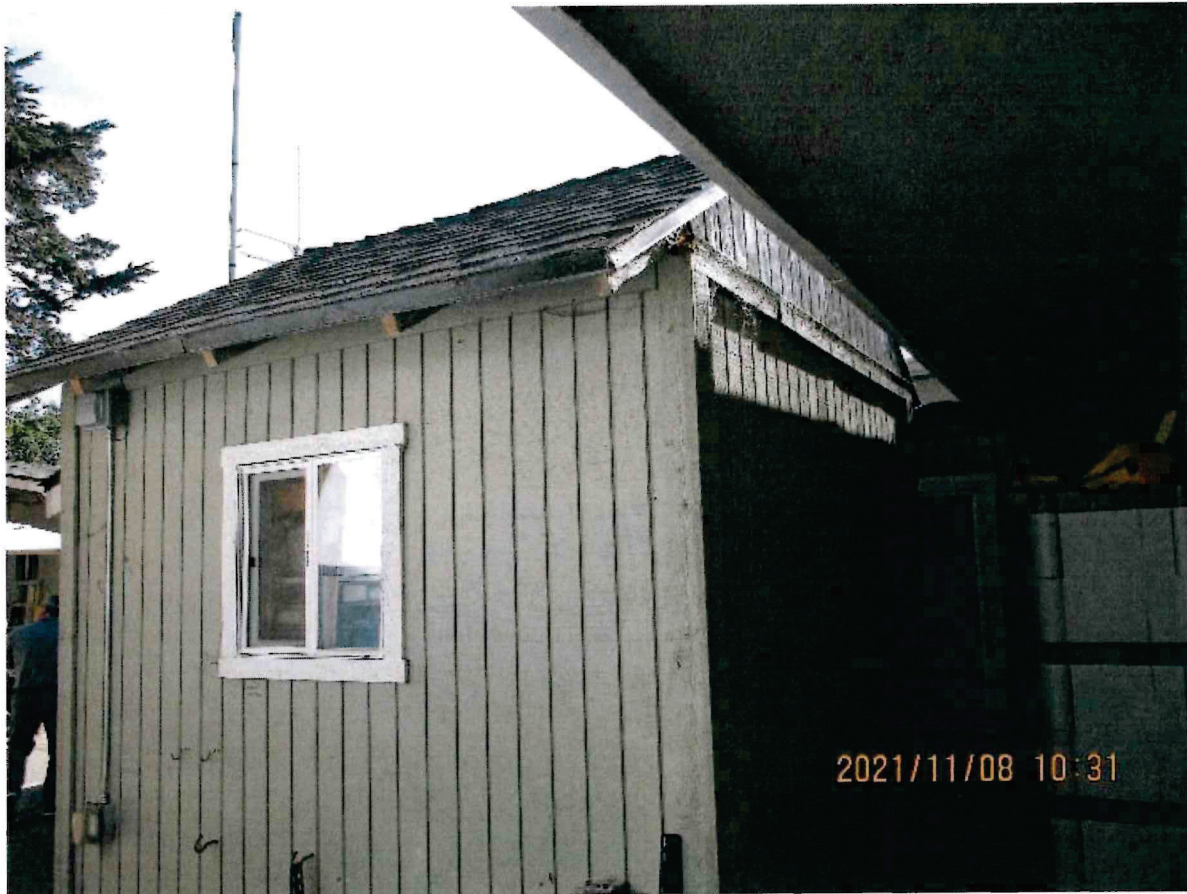
Photo 4.1. View of abandoned condemned Vehicle Garage due to conditions and proximity to the steep hill above the garage.

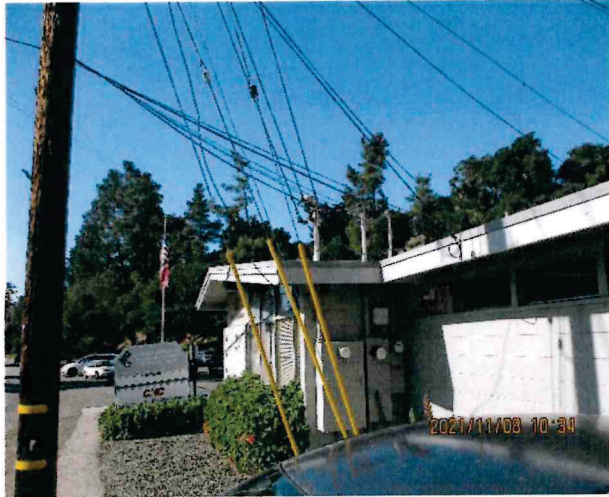
Photo 5. PG&E Laterals for four (4) Services

- (4) Recommend for any future PG&E service connection to replace (E) four service laterals with a single new underground primary service.

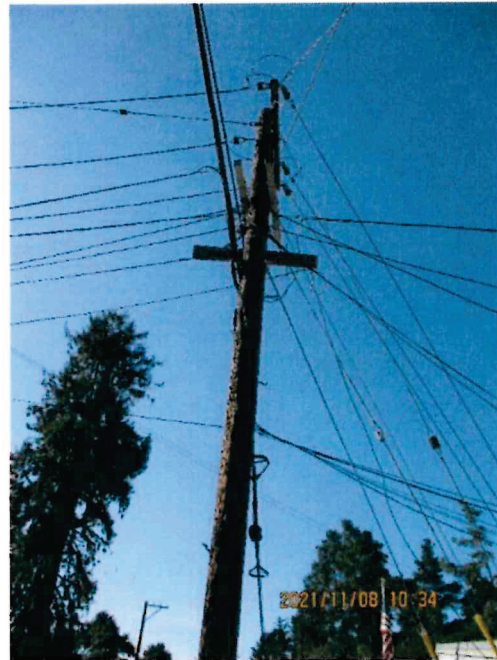
Photo 6. PG&E Electric Service Pole

Power lines shown above demonstrate insufficient power reliability and quality versus best practice public utility power service underground. Recommend existing 120/240Volt Single Phase, 3-Wire power be demolished. Suggest new underground laterals, transformer and switchgear rated 480/277 Volt, 3-Phase, 4-wire system.

The Cambria Community Healthcare District provides a critical public fire-life-safety type service mission, and recommend PG&E utility likewise, should demonstrate a best practice to mitigate risk of interruption in service, replace the hodge-podge existing observed obsolete power pole, transformer and multiple connected loads.

Recommend PG&E provide upgrade of future service with a compliant 12-15KV, 3-phase delta power system, and transformer service with Main Switchgear rated 1200Amp, 480/277Volt, 3-phase, 4-wire power system. This recommendation applies to any new project planned for this site to replace the existing obsolete building and facilities.

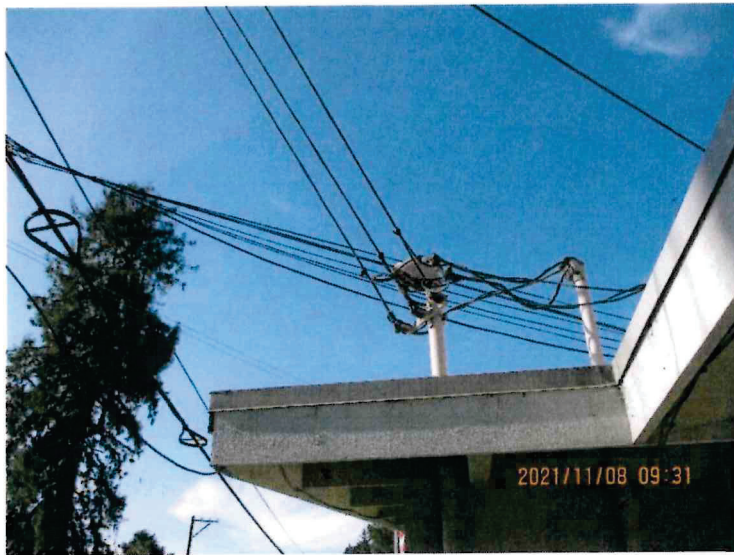
Photo 6.1 Utility Electric Service Pig-tails and Hodge-podge wiring

NEC Section 230.2 guidelines define service to a single service entrance connection.

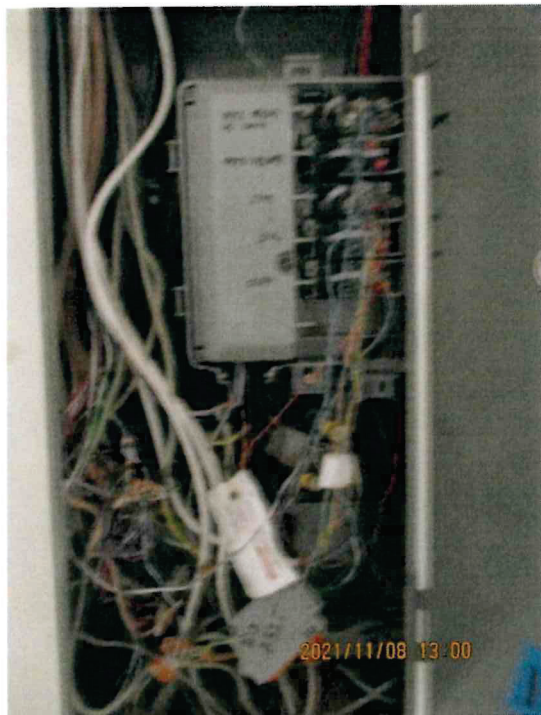
Photo 9. Wire Gutter Panel – Low Voltage Wiring

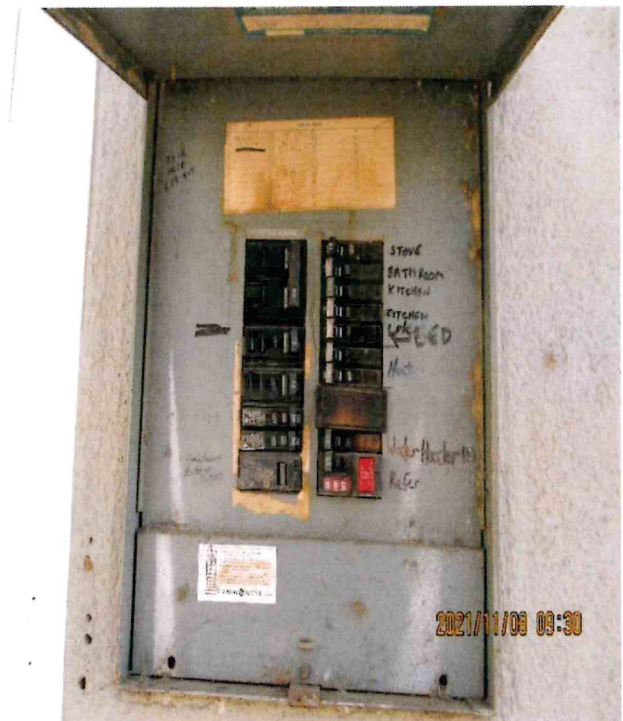
Multiple meters, inadequate panelboards, suspect over current protection, grounding and sizing of conductors, breaker set points, interrupting fault current ratings. Power distribution equipment overall is obsolete and non-repairable. Low voltage wiring is deficient including grounding, routing, labeling, circuit identification, and connections are observed holistically non-compliant and at risk of cross connections throughout.

View 10. Power Distribution Panelboard

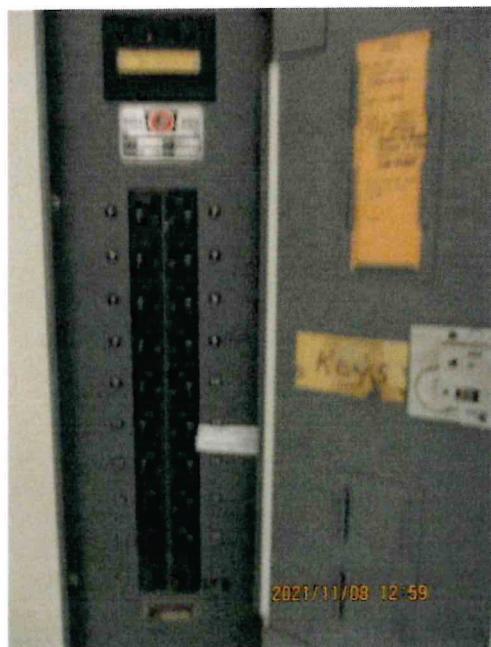
Photo 11. Power Distribution Panelboard #2

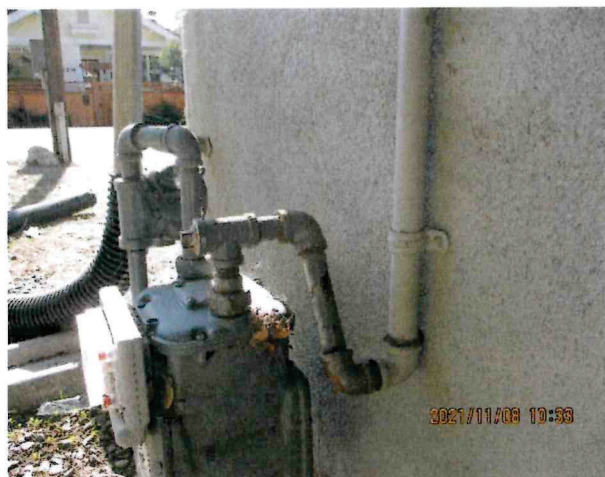
Photo 14. Gas Meter

In Photo's 13, and 14, the gas service is inadequate, such as pipe route, protection, regulator type, size, and function. Pipe is routed on outside of building, no turnoff valves, no safety devices, and no identification.

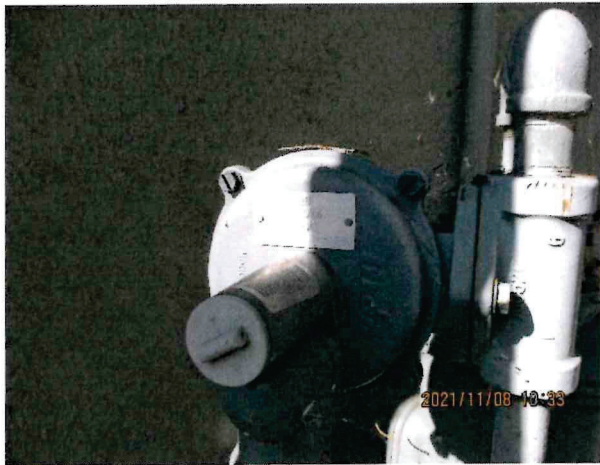
Photo 15. Gas Service Regulator

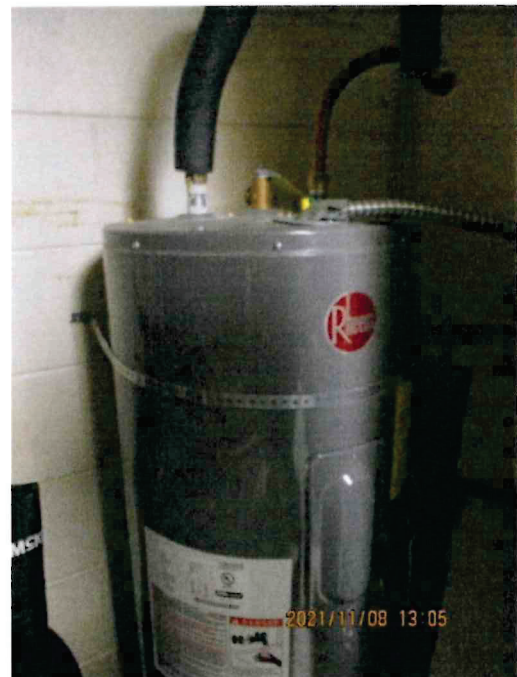
Gas was used to serve a gas hot water heater, which appears to be disconnected, and replaced by electric water heater located in the building. The old gas connected remains as observed with potential risk of a gas leak.

Photo 18. (N) EWH Replaced old gas DWH

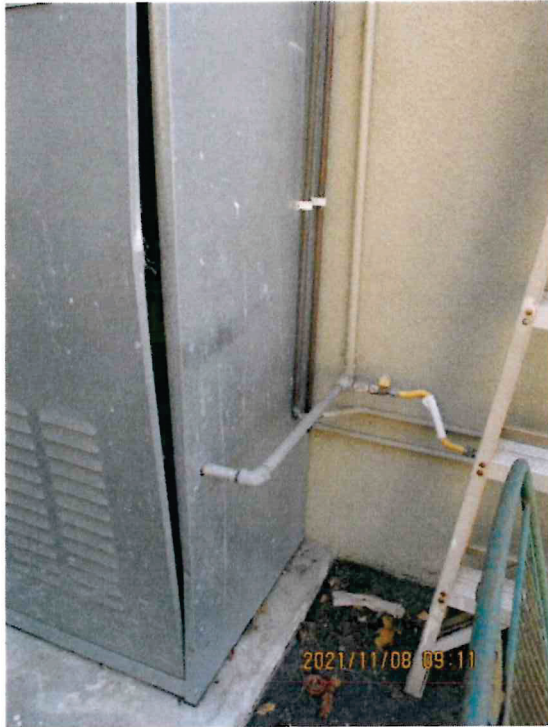
Photo 19. Non-compliant Gas connection

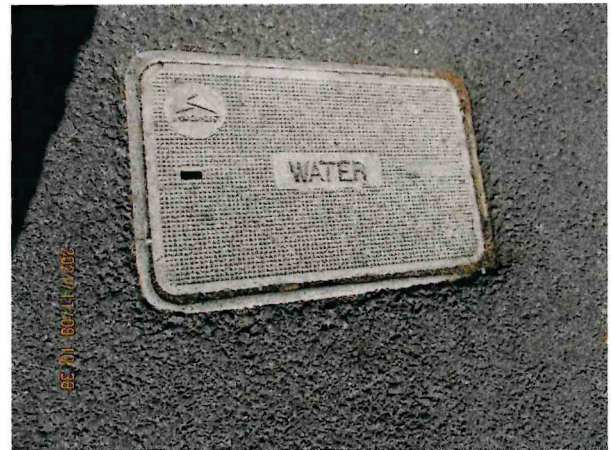
Photo 22. Domestic Water Meter

Water Service connection include water meter and backflow preventer located at the parking lot to west of the building lobby. No evidence of regular backflow testing and certification is observed.

Recommend a water quality testing and report for the domestic water service. A water softening treatment system may have been noticed during the brief spot checks of building domestic water plumbing fixtures at the building break room and toilet rooms. Evidence of mice intrusion was also observed.

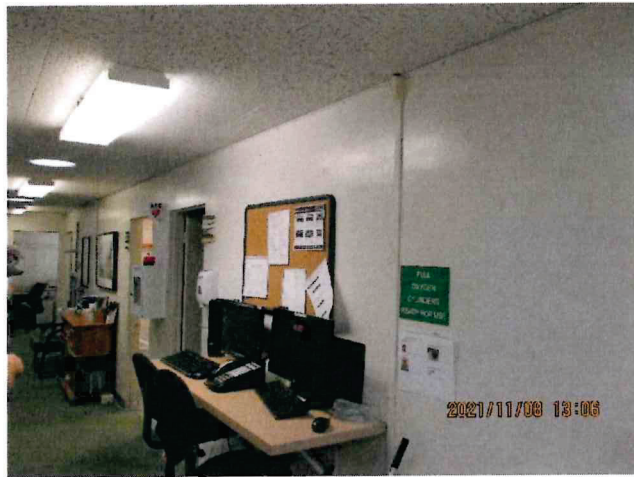
Photo 23. Example Building Interior Hallway

Communications wiring in Photo 23, is observed installed at the upper corner of the Hallway. This location for cable installation was due to reported hazardous material present above ceiling in plenum area, which was reported to be non-accessible due to hazardous materials present above the ceiling.

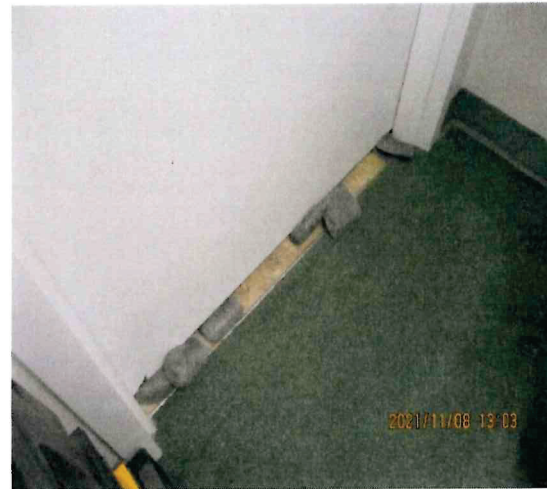
Photo 24. Steel Wool Placed Under Door

The steel wool is observed under the door in Photo 24, which was reported placed there, which helps to keep the mice away from intrusion as mice will not eat the steel wool material, which is reported as an on-going issue.

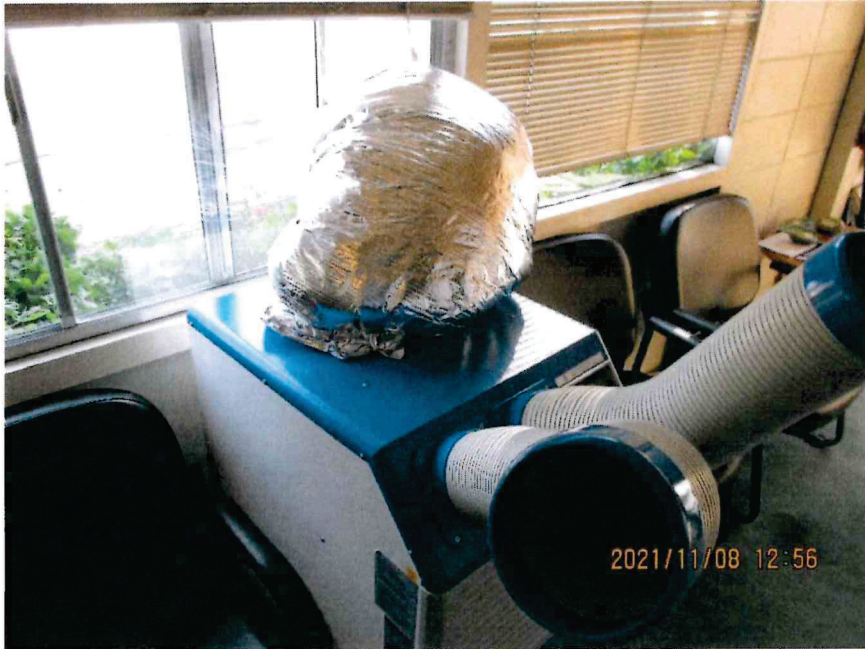
Photo 25. A Portable Evaporative Cooler – One for the Whole Building

In Photo 25, a single evaporative cooler is observed at the Lobby area, which purpose is to provide cooling fresh air throughout the building... one such unit is insufficient to provide the whole building indoor air and climate control throughout occupied areas. At hallways and the Lab area, little to no air flow was observed.

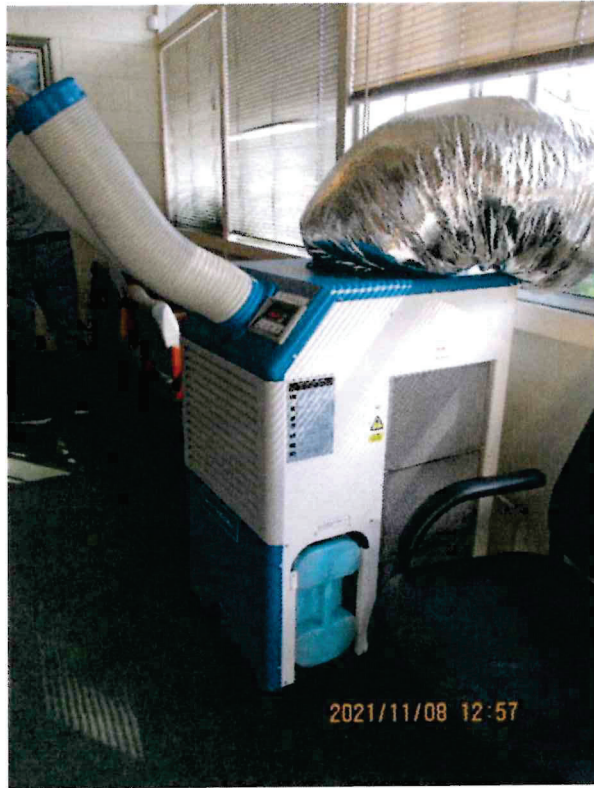
Photo 26. Evaporative Cooler at Lobby Entrance

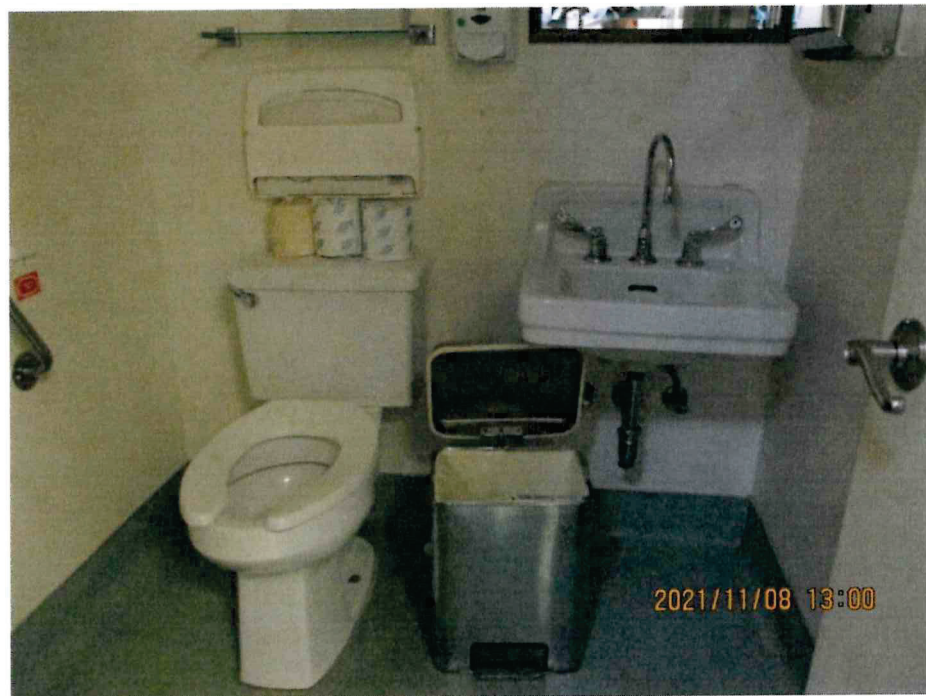
Photo 27. Non-compliant Toilet facilities - no exhaust, no ventilation, and ADA non-compliant.

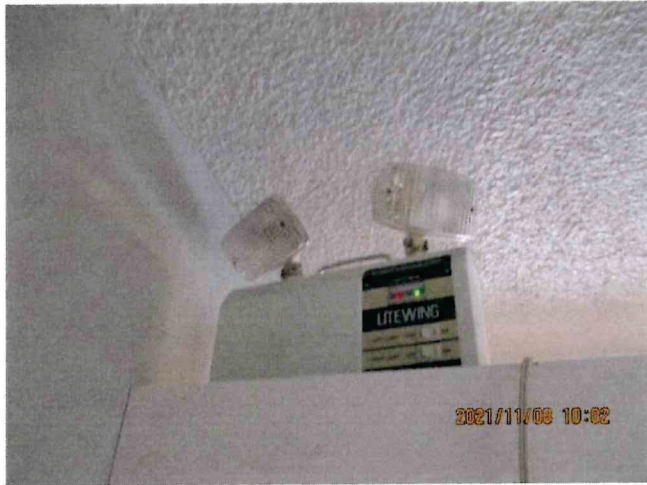
Photo 28. Emergency lighting. HAXMAT materials above

Observe branch power distribution and emergency lighting is inadequate and non-repairable throughout. Any new scope of work or repairs to mitigate observed issues – would be considered a waste of resources. Wiring issues and overall circuitry and points of connection are obsolete, past any service life cycle, and non-repairable.

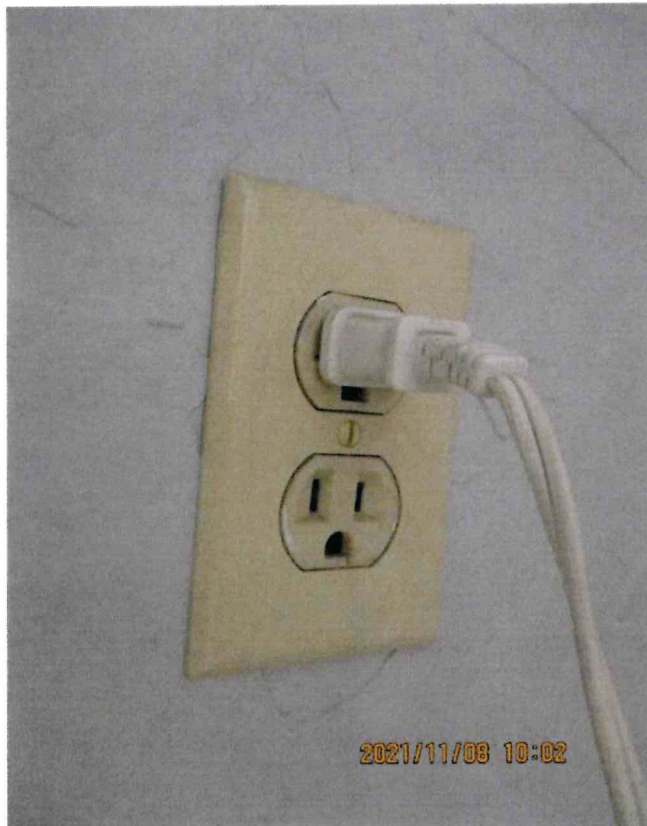
Photo 29. Non- compliant branch circuits and outlets

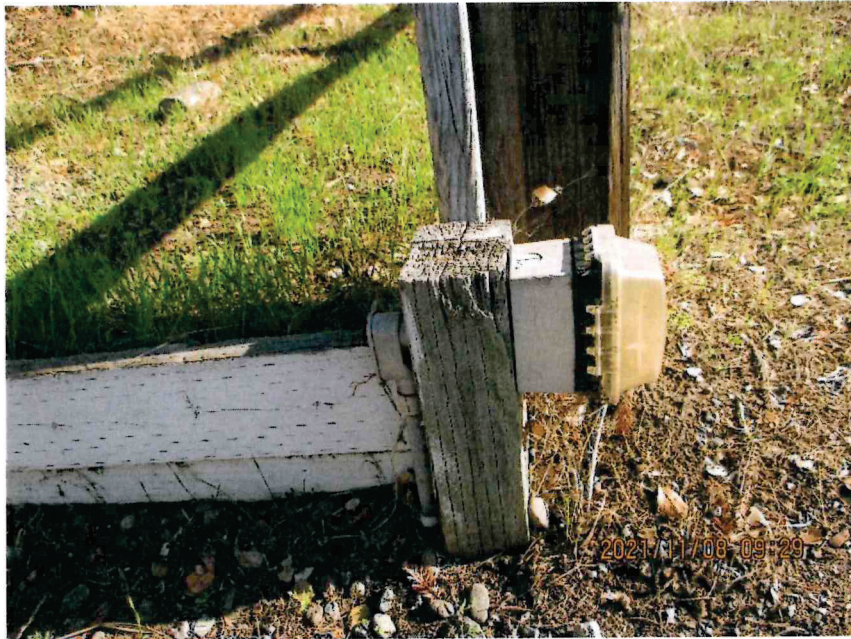
Photo 30. Non-compliant Exterior Convenience Outlet

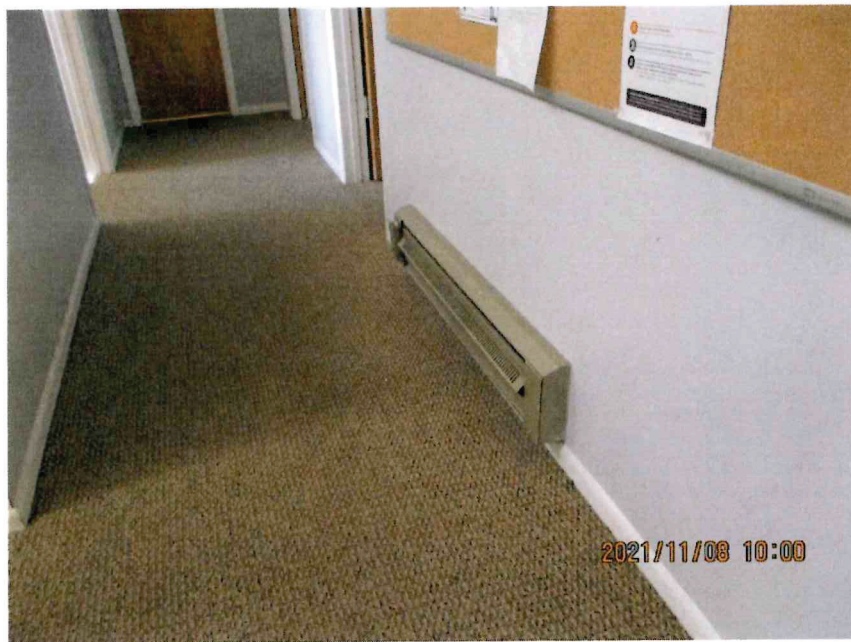
Photo 31. Example of Interior Non-operable Wall-mount Baseboard Heaters

In Photo 31, an obsolete baseboard radiator is observed. No building heating is provided. Occupants bring their own portable heaters to occupied spaces as needed. Numerous breaker interruptions occur routinely.

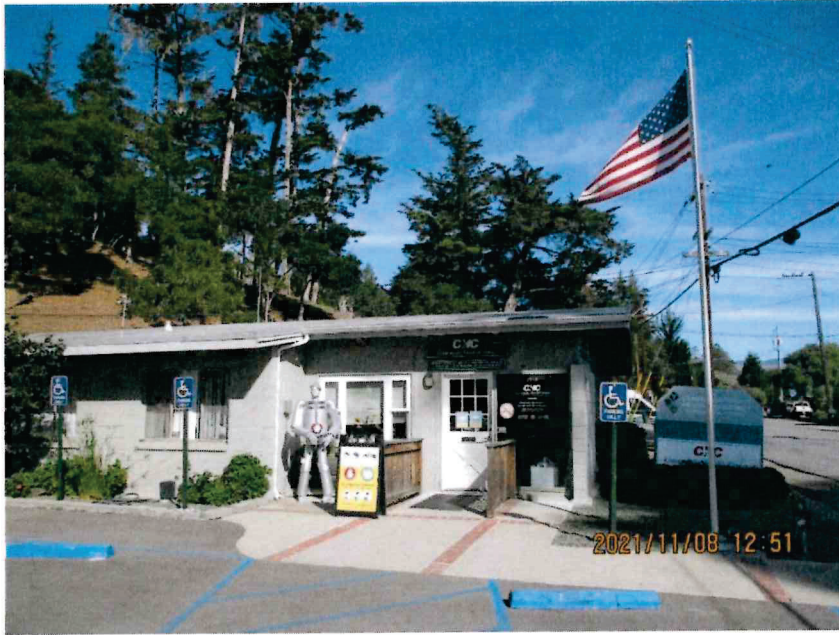
Photo 32. Cambria Community Healthcare District Services Facility

In Photo 32, the front office lobby is observed to right of the *Tin-Man* with temporary portable evaporative air-conditioner protruding out the window facing Main Street. No building central air-conditioning, or building heating is provided. Occupants bring portable heaters, when needed. There is no central ventilation.

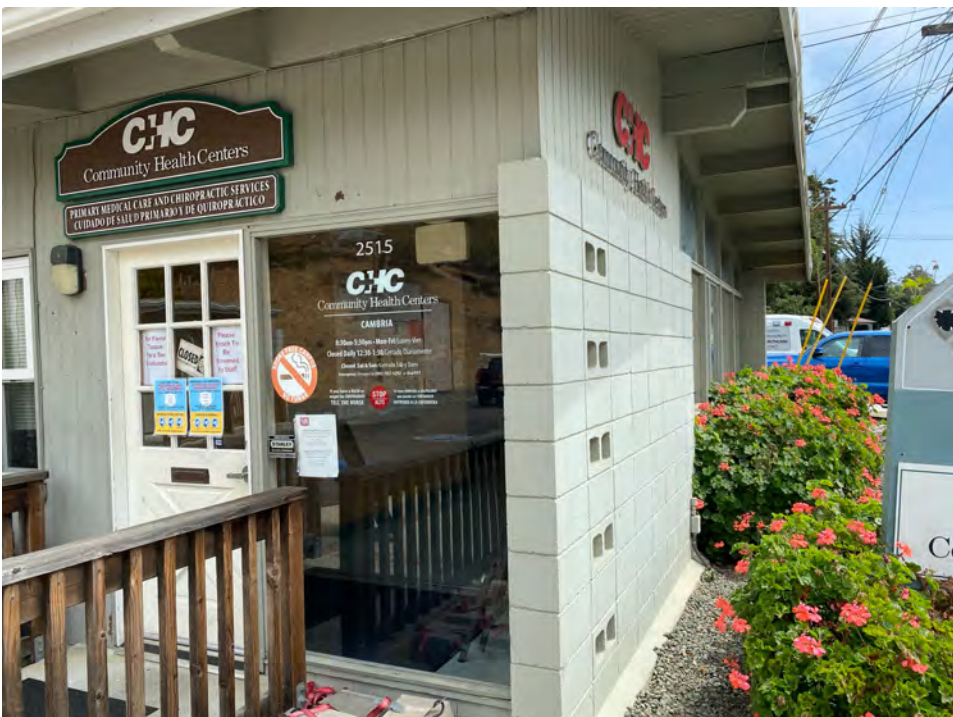
**Photo 9- Gray Wood Trim & Siding- 2515 Main St.- Exterior-
Lead-Containing Paint (Fair Condition)**

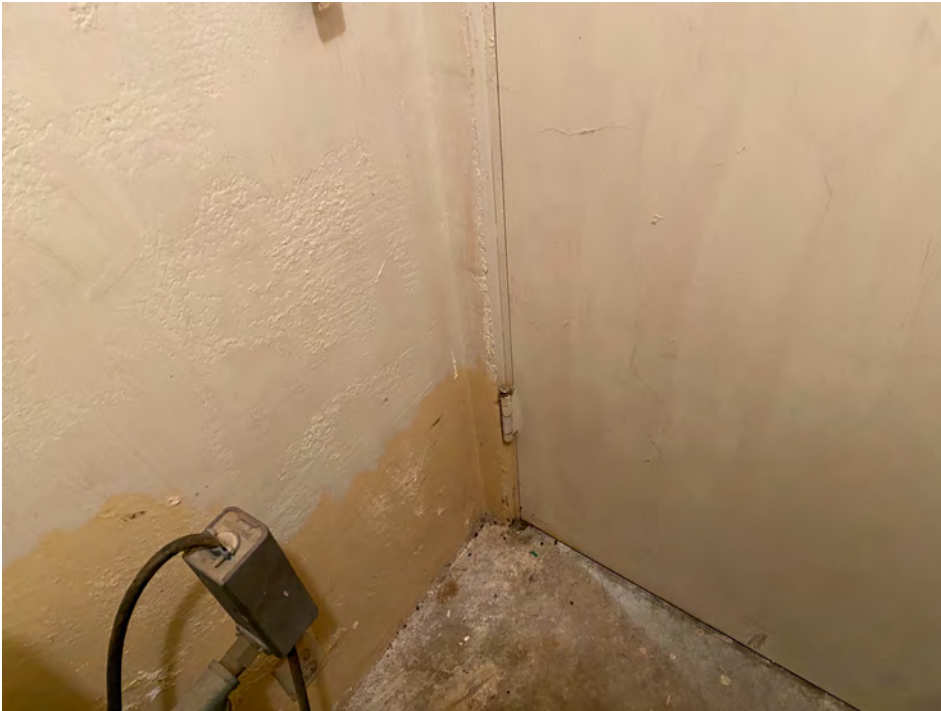
**Photo 12- White Plaster Walls, White Wood Door & Casing- 2515 Main St.-
CHC Area- Lead-Containing Paint & LBP (Good Condition)**

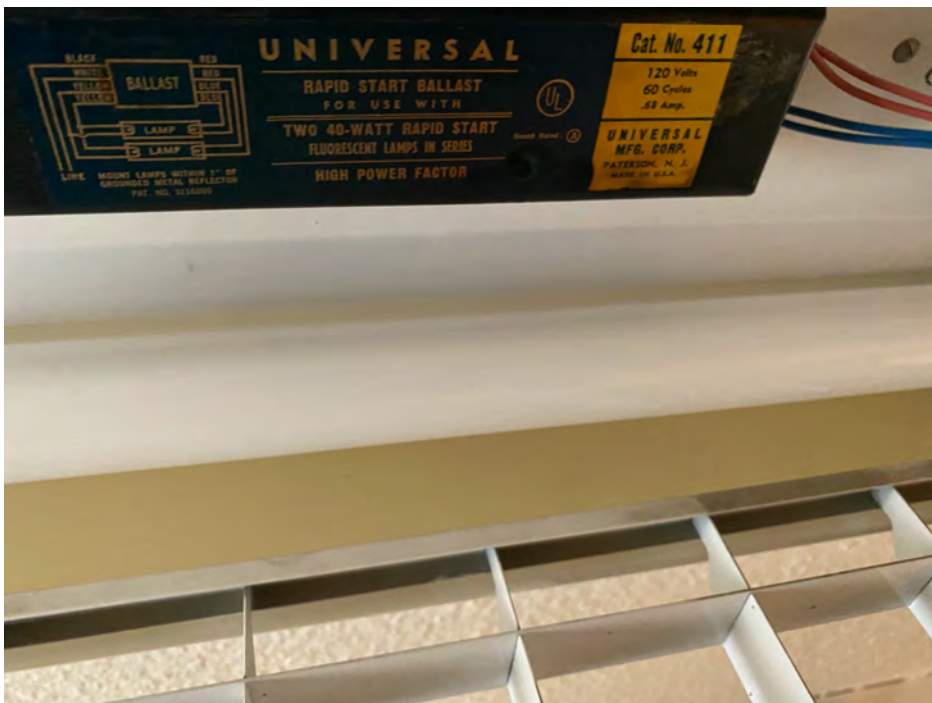
**Photo 16- Mercury-Containing Light Tubes in Light Fixtures-
2515 & 2535 Main St.- Throughout Area**

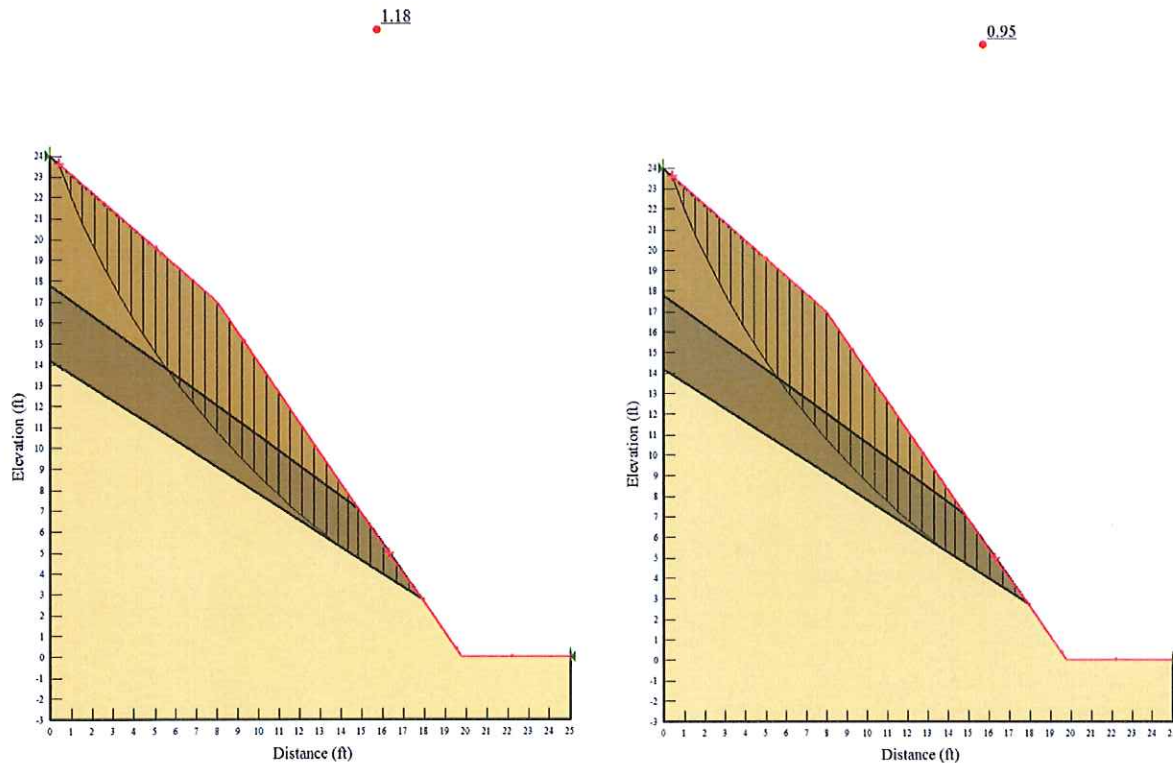
The pseudo-static (seismic) stability analyses performed for the slope configurations shows the **critical pseudo-static factor of safety values are below the minimum standard (1.15), indicating that they reflect unstable conditions.**

Figure 5: Trench T-1, (Static, value of 1.18, pseudo-static value of 0.95)
