Cambria Community Healthcare District
2535 Main Street, Cambria, CA

Facility Condition Assessment & Report

**Orry Nottingham PE CAP Inc.
Commissioning Authority & Professional Engineer
November 8, 2021**

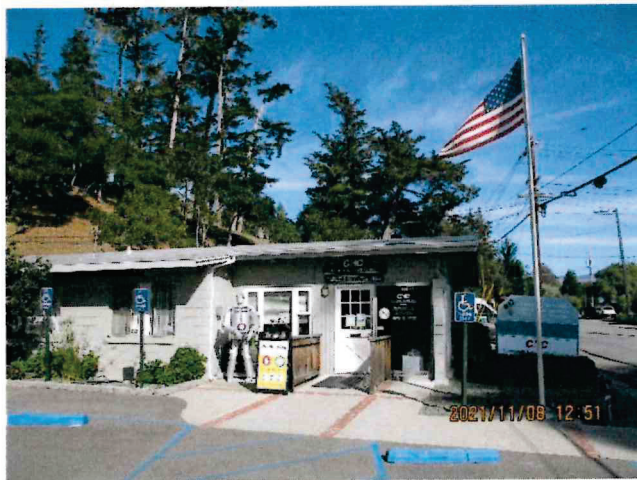
Photo 3. View from Parking Lot to Lobby

The front lobby includes a single portable water source evaporative cooler, which attempts to provide a whole building cooling and ventilation that is woefully inadequate. Essentially, no operating heating, cooling, and/or ventilation results in poor indoor air quality, which is observed inadequate and non-compliant.

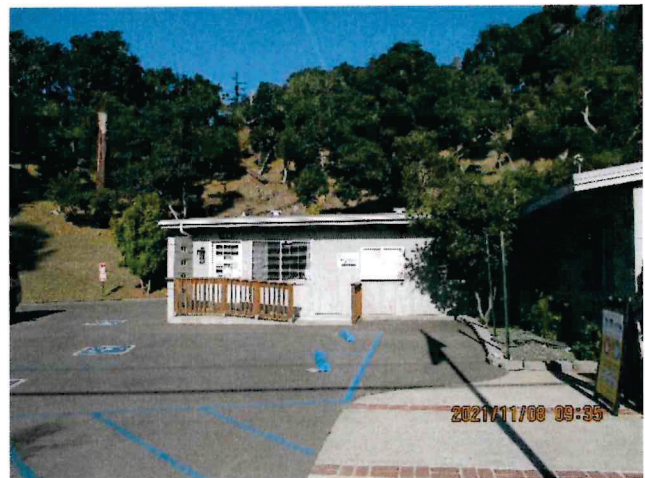
Photo 4. View from Parking Lot to Office

From this view can be seen the four PG&E electric service laterals (upper right), and water service meter and backflow preventer (lower right), and a gas service pipe and regulator (far back lower SE corner of building).

- (4) Recommend for any future PG&E service connection to replace (E) four service laterals with a single new underground primary service.

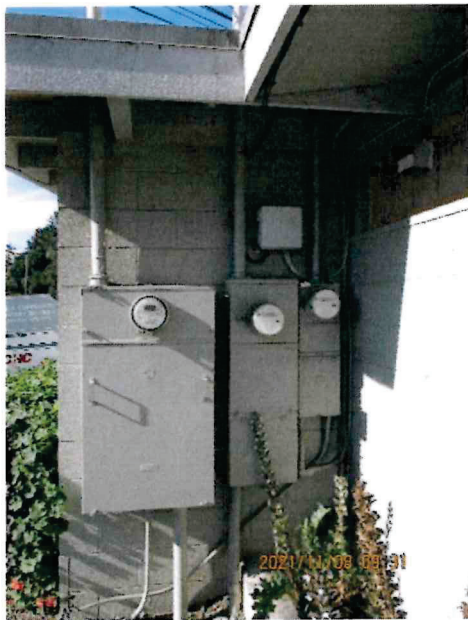
Photo 7. PG&E Services #1, 2, and 3

NEC Section 230.2 guidelines define service to a single service entrance connection.

Multiple service laterals are observed noncompliant with National Electric Code (NEC) Article 250 Grounding and Bonding, and ARC-flash protection. Observe no grounding electrode conductors for building secondary power distribution panels.

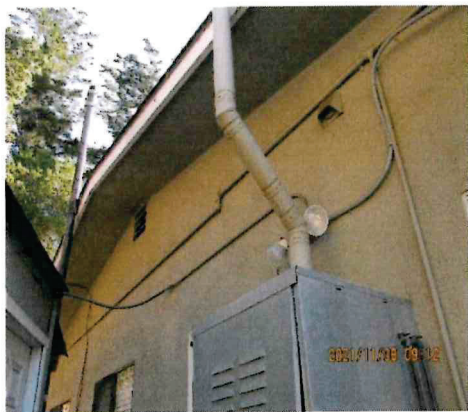
Photo 17. Gas Line Runs on side of building to DWH

Gas was used to serve a gas hot water heater, which appears to be disconnected, and replaced by electric water heater located in the building. The old gas connected remains as observed with potential risk of a gas leak.

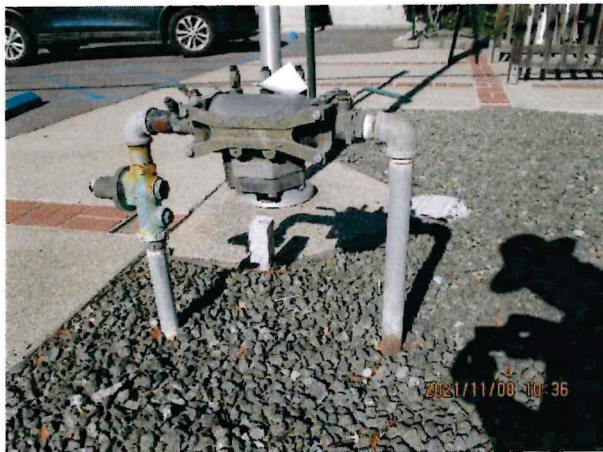
Photo 21. Domestic Water Backflow Preventer

Water Service connection include water meter and backflow preventer located at the parking lot to west of the building lobby. No evidence of regular backflow testing and certification is observed.

Recommend a water quality testing and report for the domestic water service. A water softening treatment system may have been noticed during the brief spot checks of building domestic water plumbing fixtures at the building break room and toilet rooms. Evidence of mice intrusion was also observed.

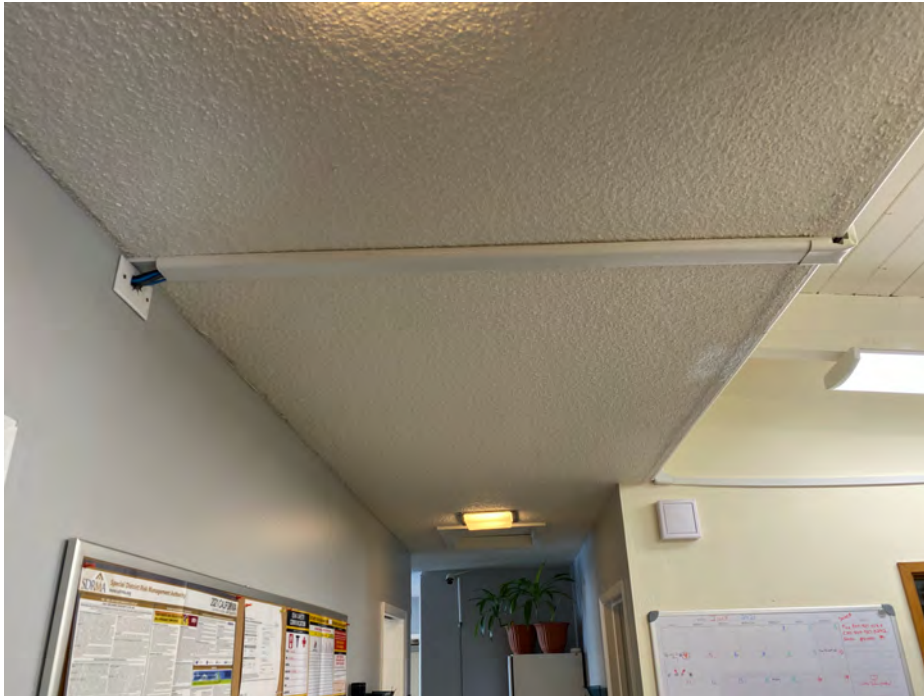
**Photo 1- Spray-Applied Acoustic Ceiling Material & Joint Compound
Assoc. w/ Drywall Walls & Ceilings- 2515 Main St.- CCHD Office Area- ACM**

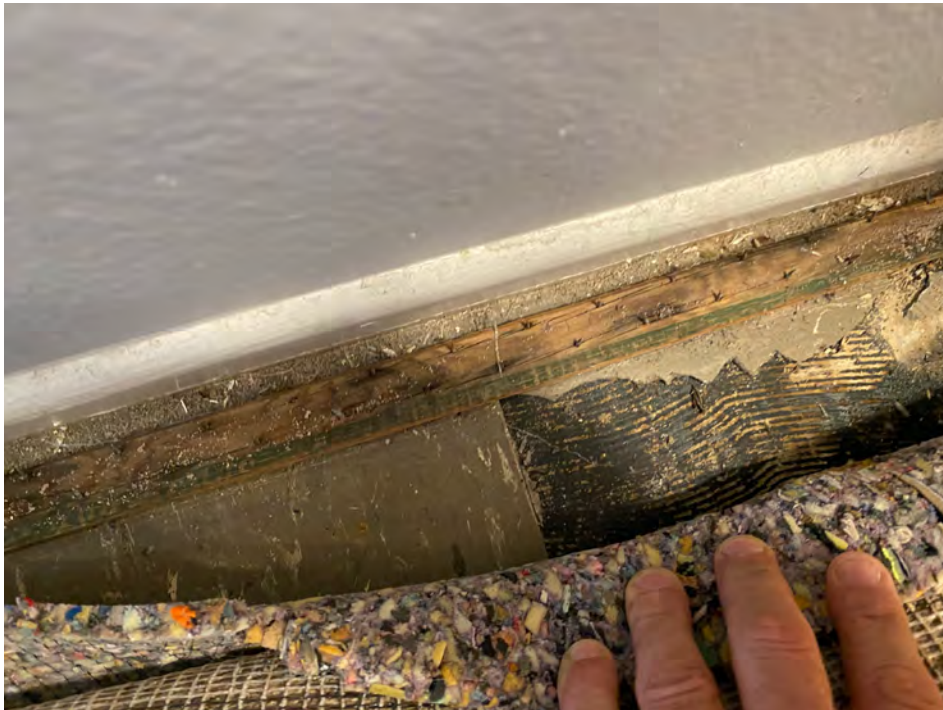
**Photo 2- Gray 9" x 9" Floor Tile (Under Carpet & Sheet Flooring)-
2515 Main St.- CCHD Office Area- ACM**

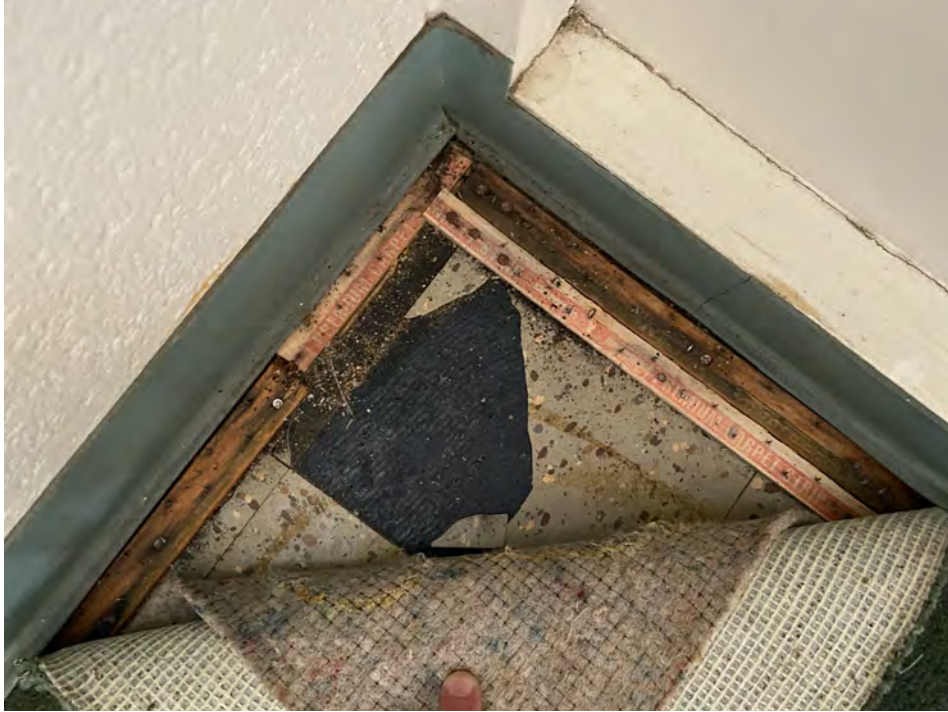
**Photo 5- Gray Speckled 9" x 9" Floor Tile & Black Mastic (Under Carpet)-
2515 Main St.- CHC Office Area- ACM**

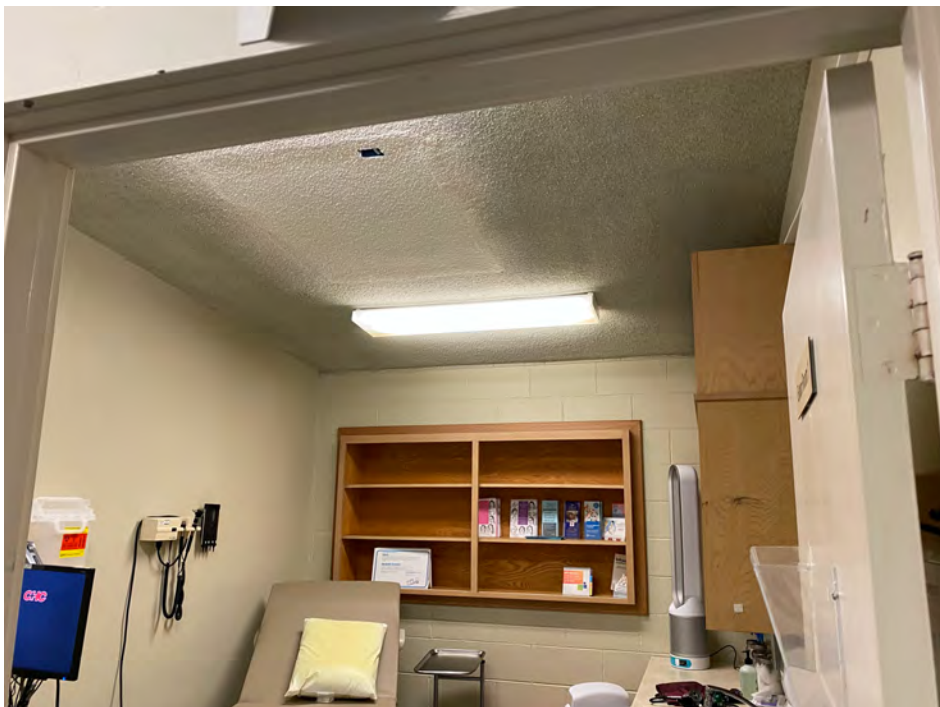
Photo 6- Spray-Applied Acoustic Ceiling Material- CHC Office Area- ACM

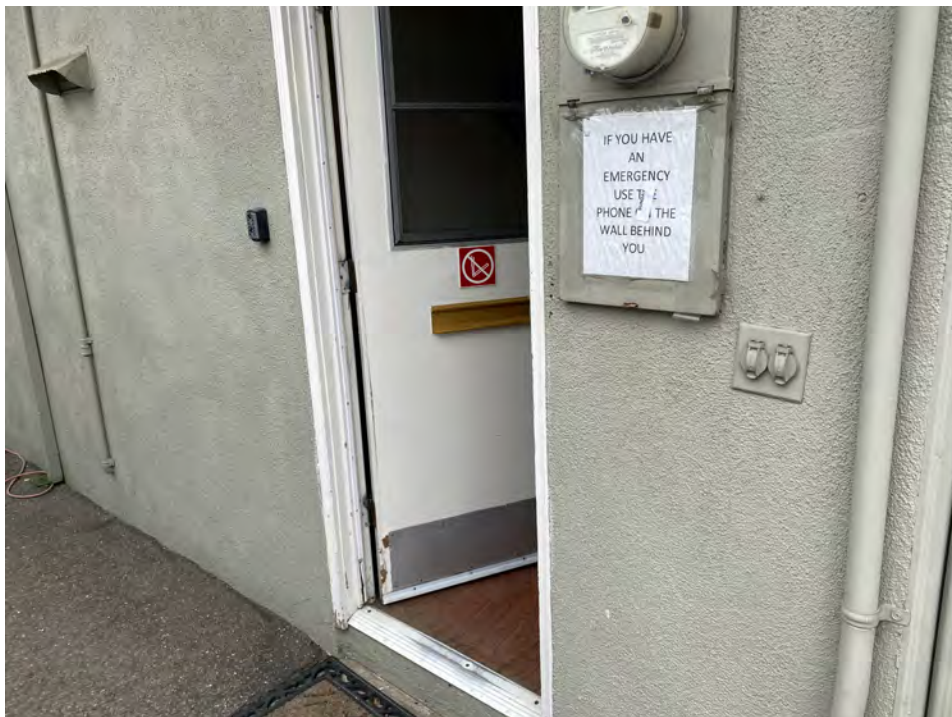
**Photo 14- White Wood Door Casing- 2535 Main St.- Exterior-
Lead-Containing Paint (Good Condition)**

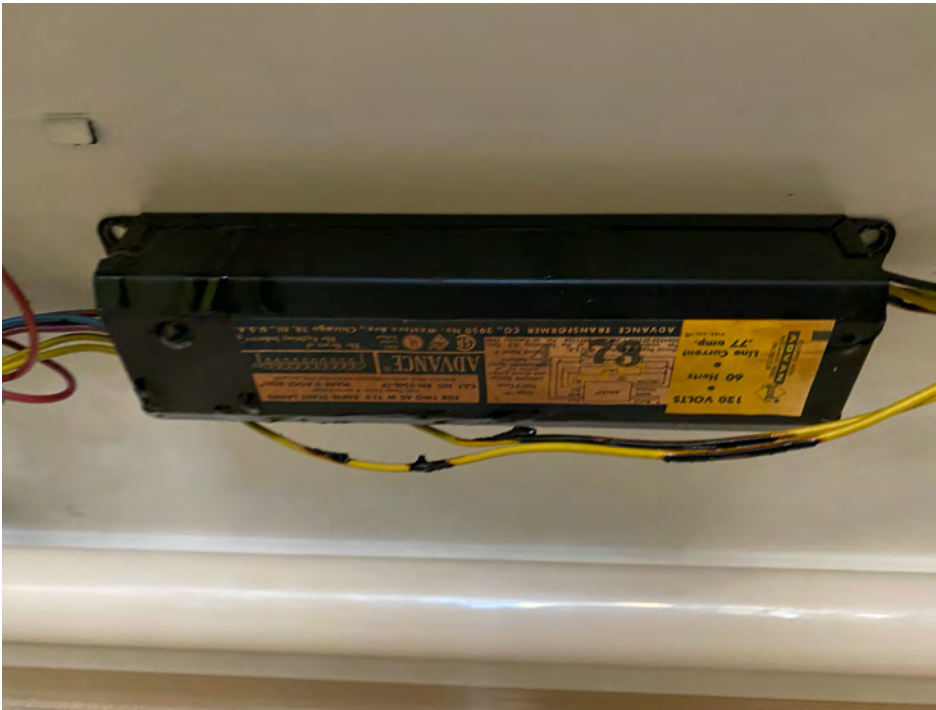
Photo 15- PCB Ballasts in Light Fixtures- 2515 Main St.- Throughout Area

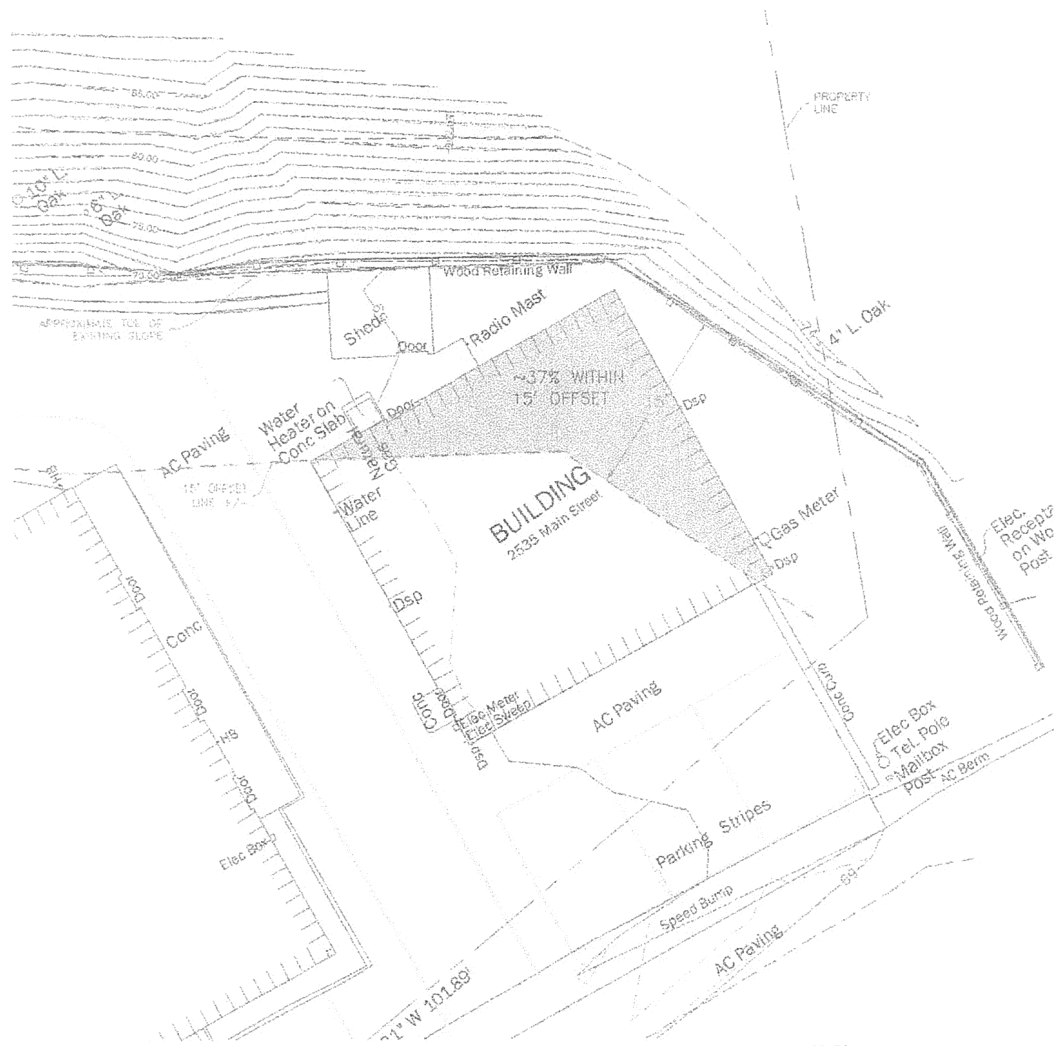
Figure 12. 15' offset from toe of bank to existing building.

Figure 12 illustrates the percentage of building within the 15' offset from the existing toe of bank. Approximately 37% (270 sq.ft.) of the existing building would be required to be removed in order to satisfy the building code requirements in lieu of a retaining structure as shown in Figure 13.

It is understood that the structure closest to the slope has historically been used to house and sleep emergency personnel. For this reason, Coast, Inc. recommends that if the building’s purpose is to sleep emergency personnel, it should be relocated at least 15 feet away from the existing toe of slope.

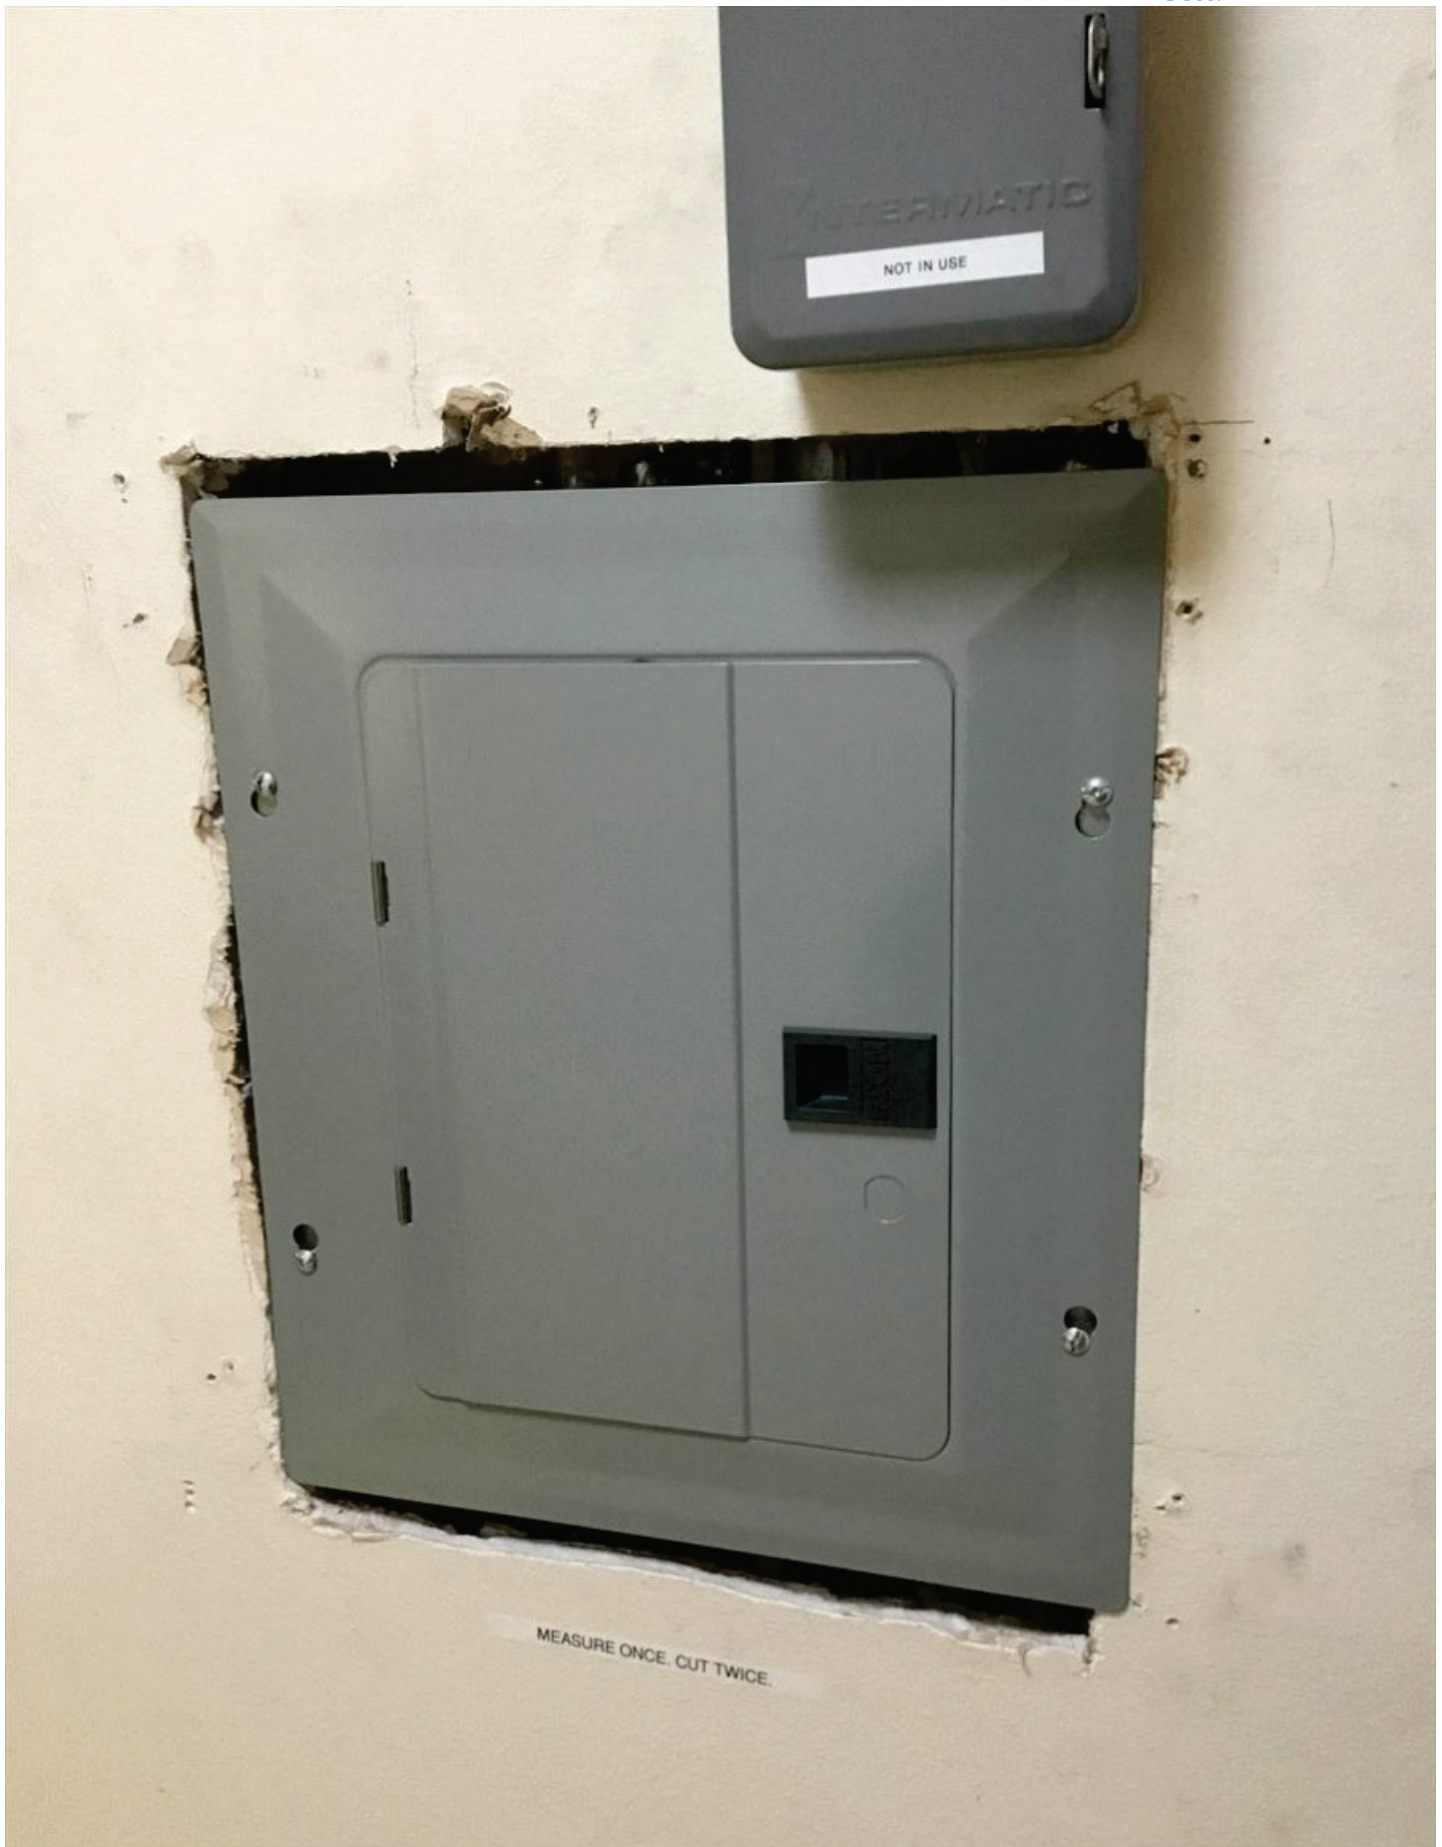
Violation Code: 701.2

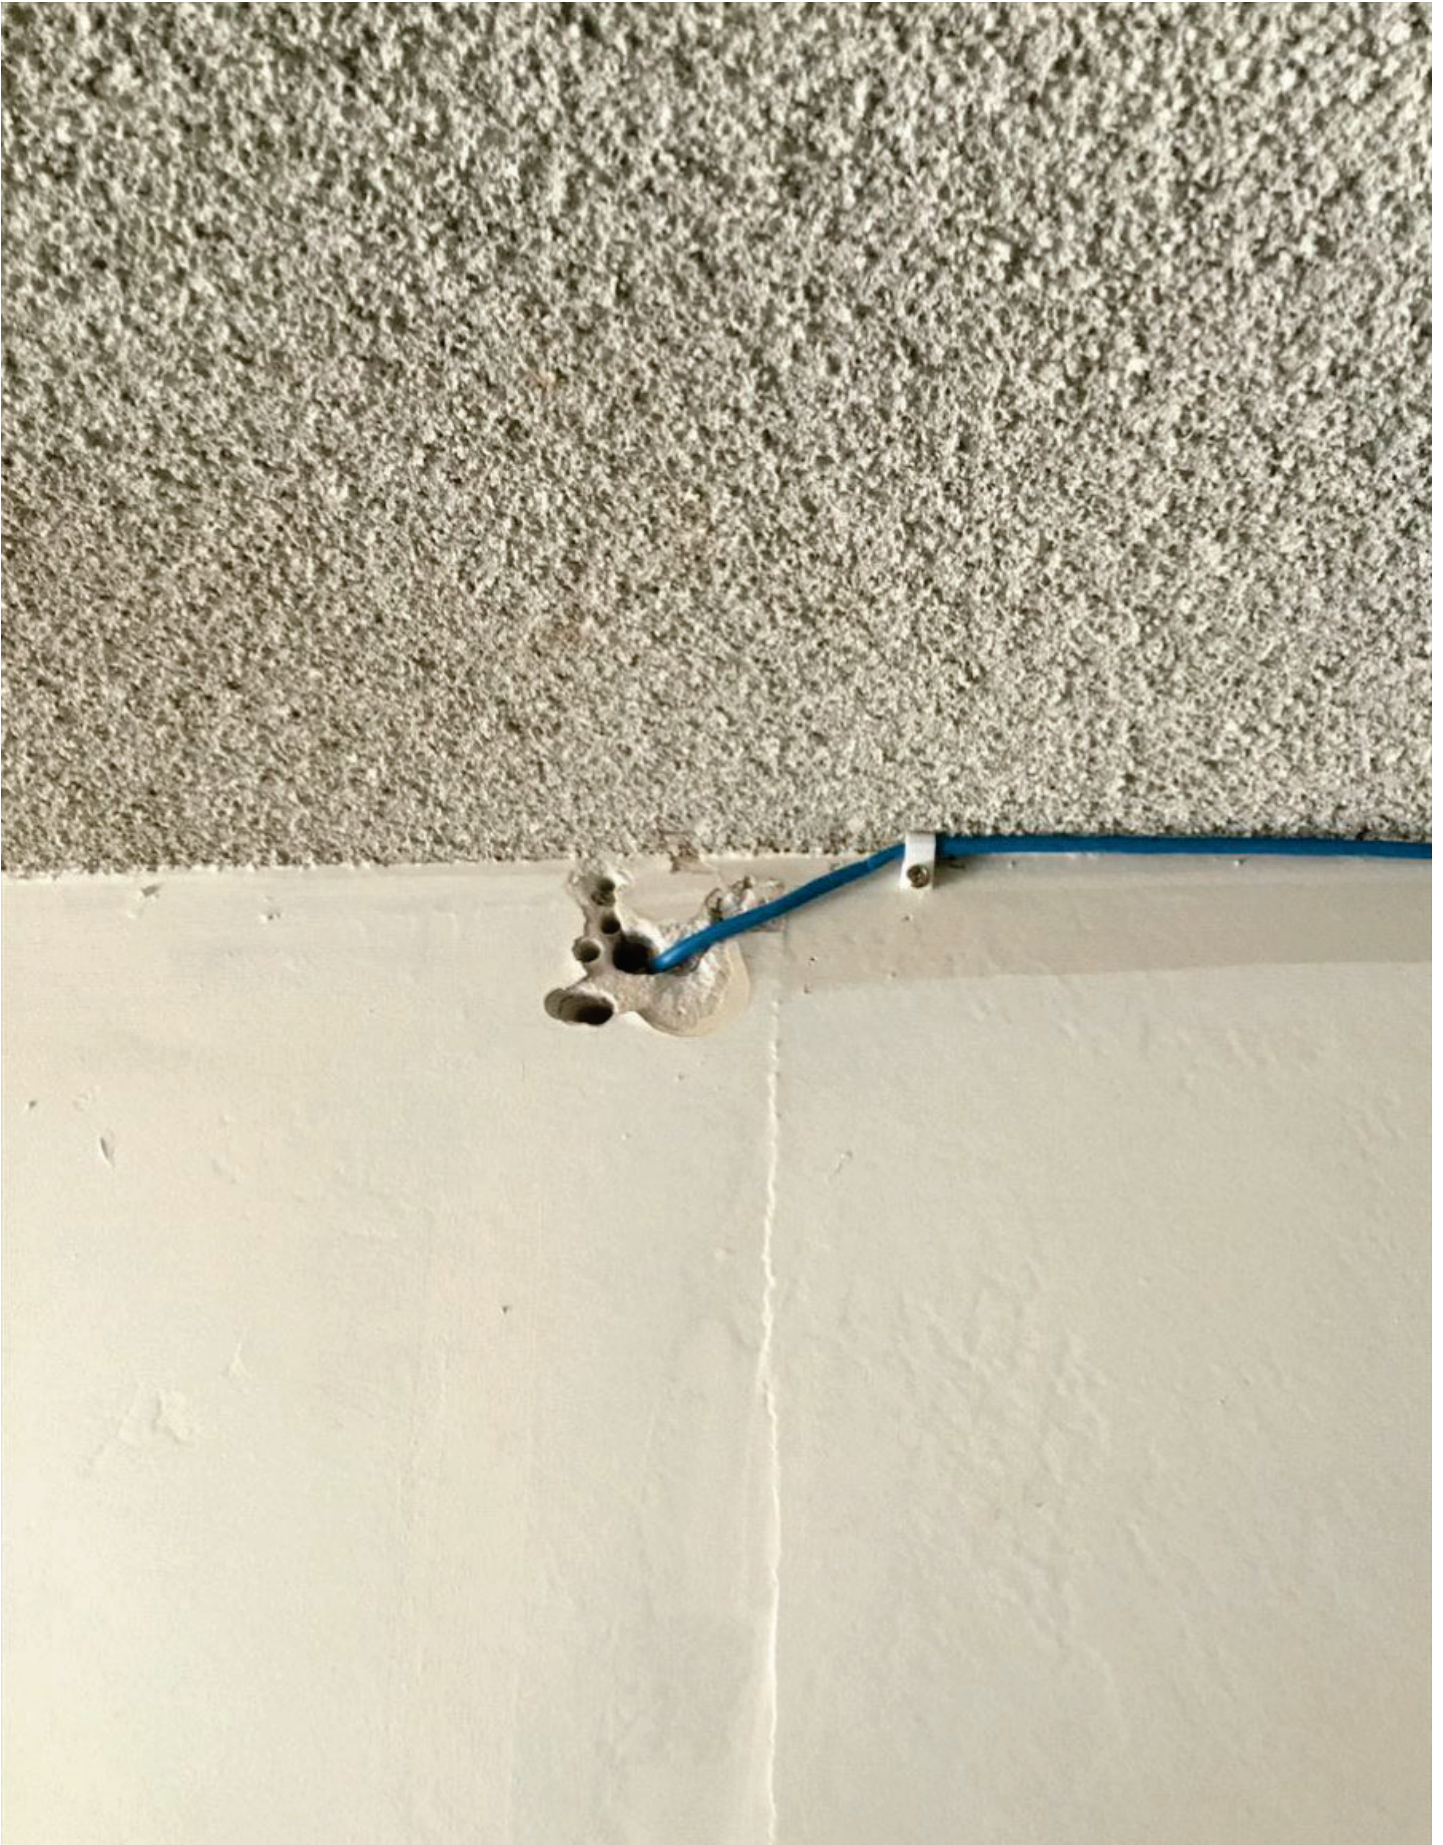
Violation Code: 701.2

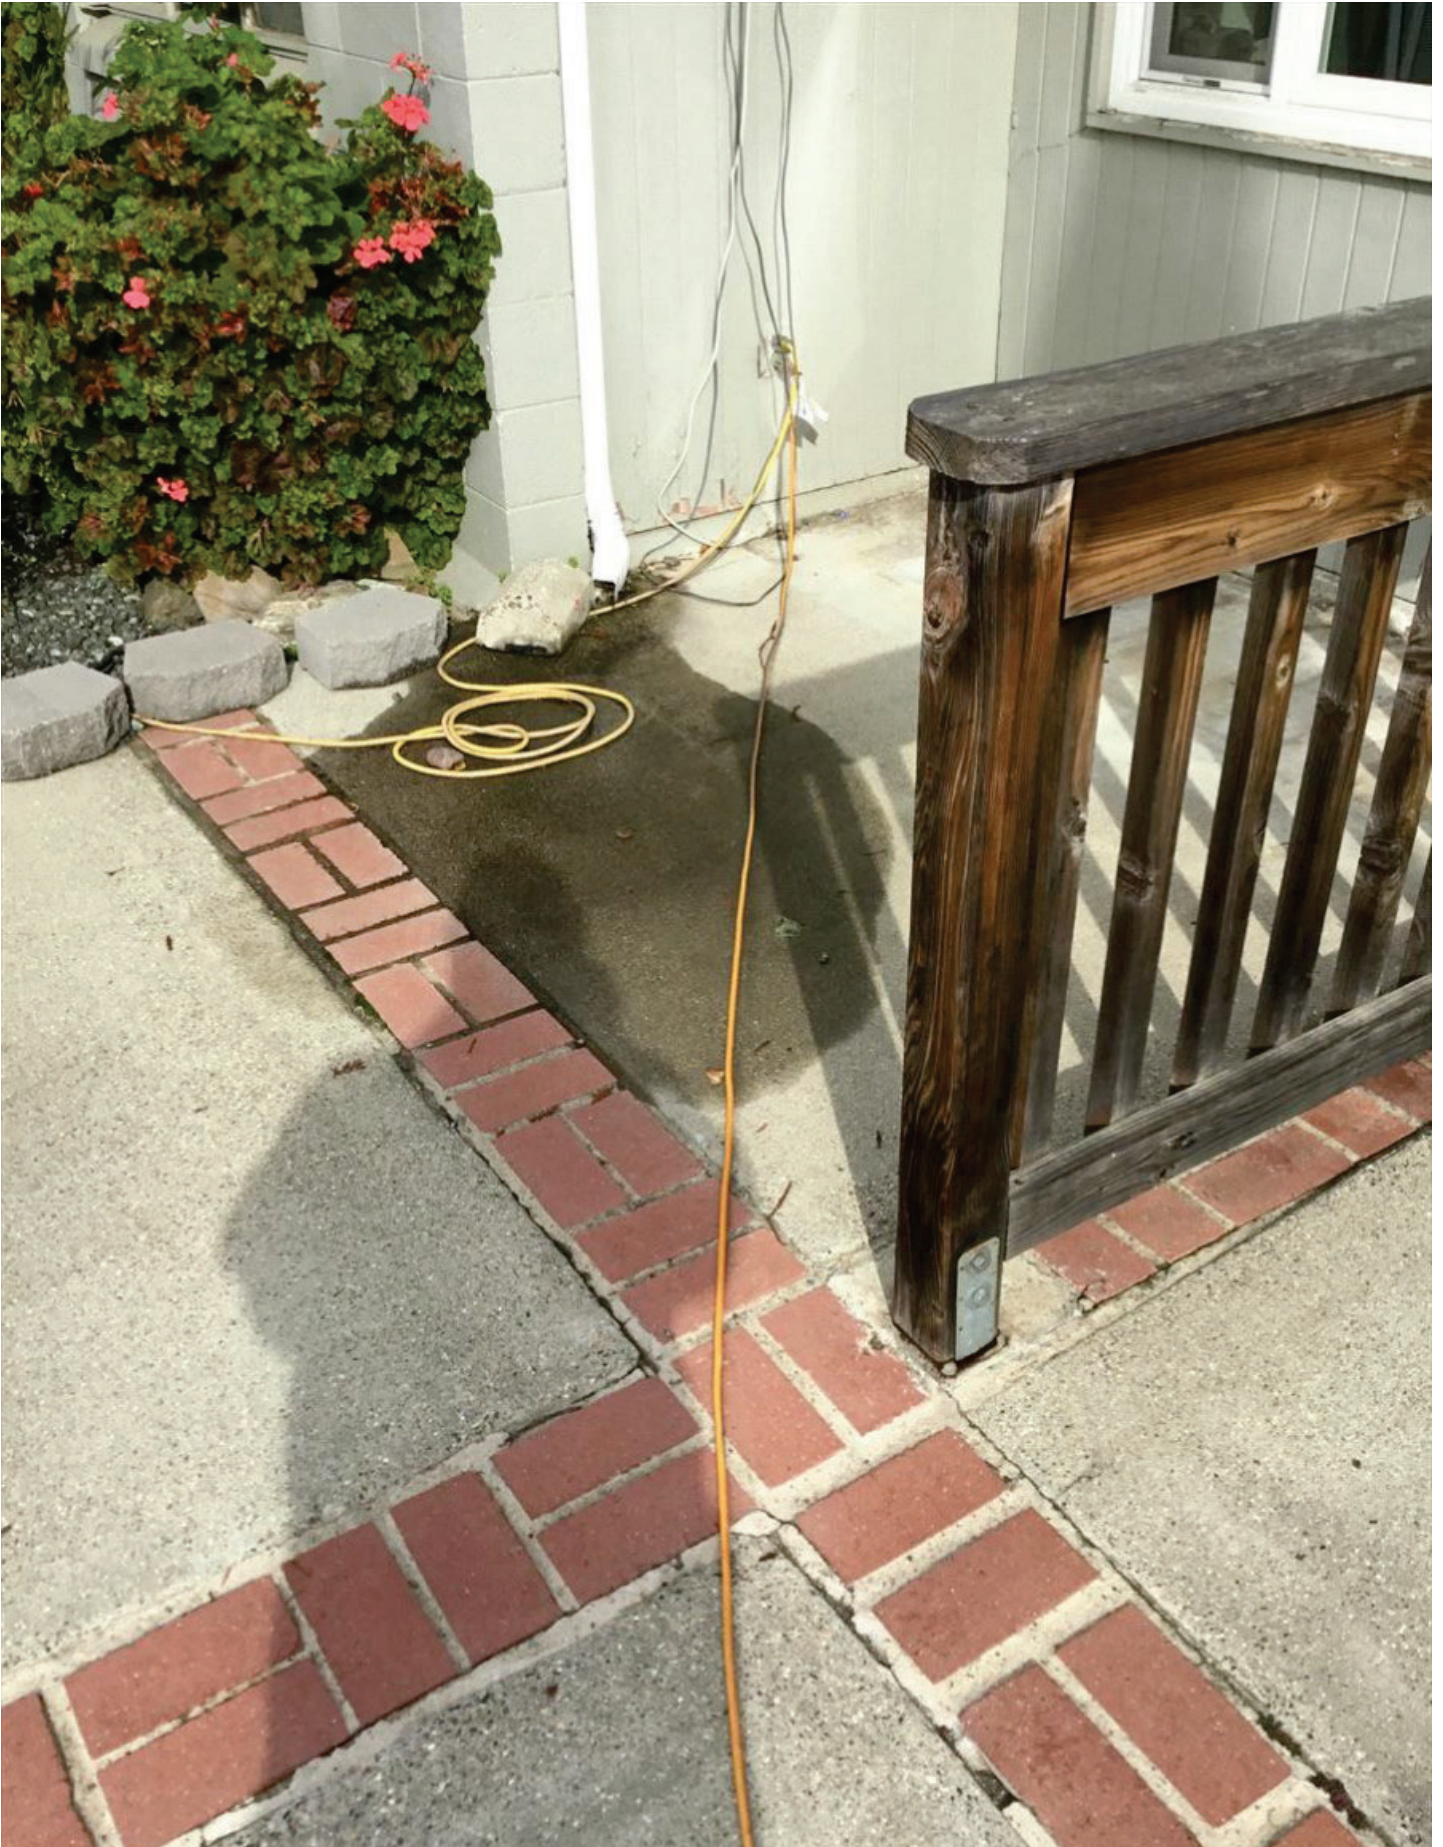
Violation Code: 604.9

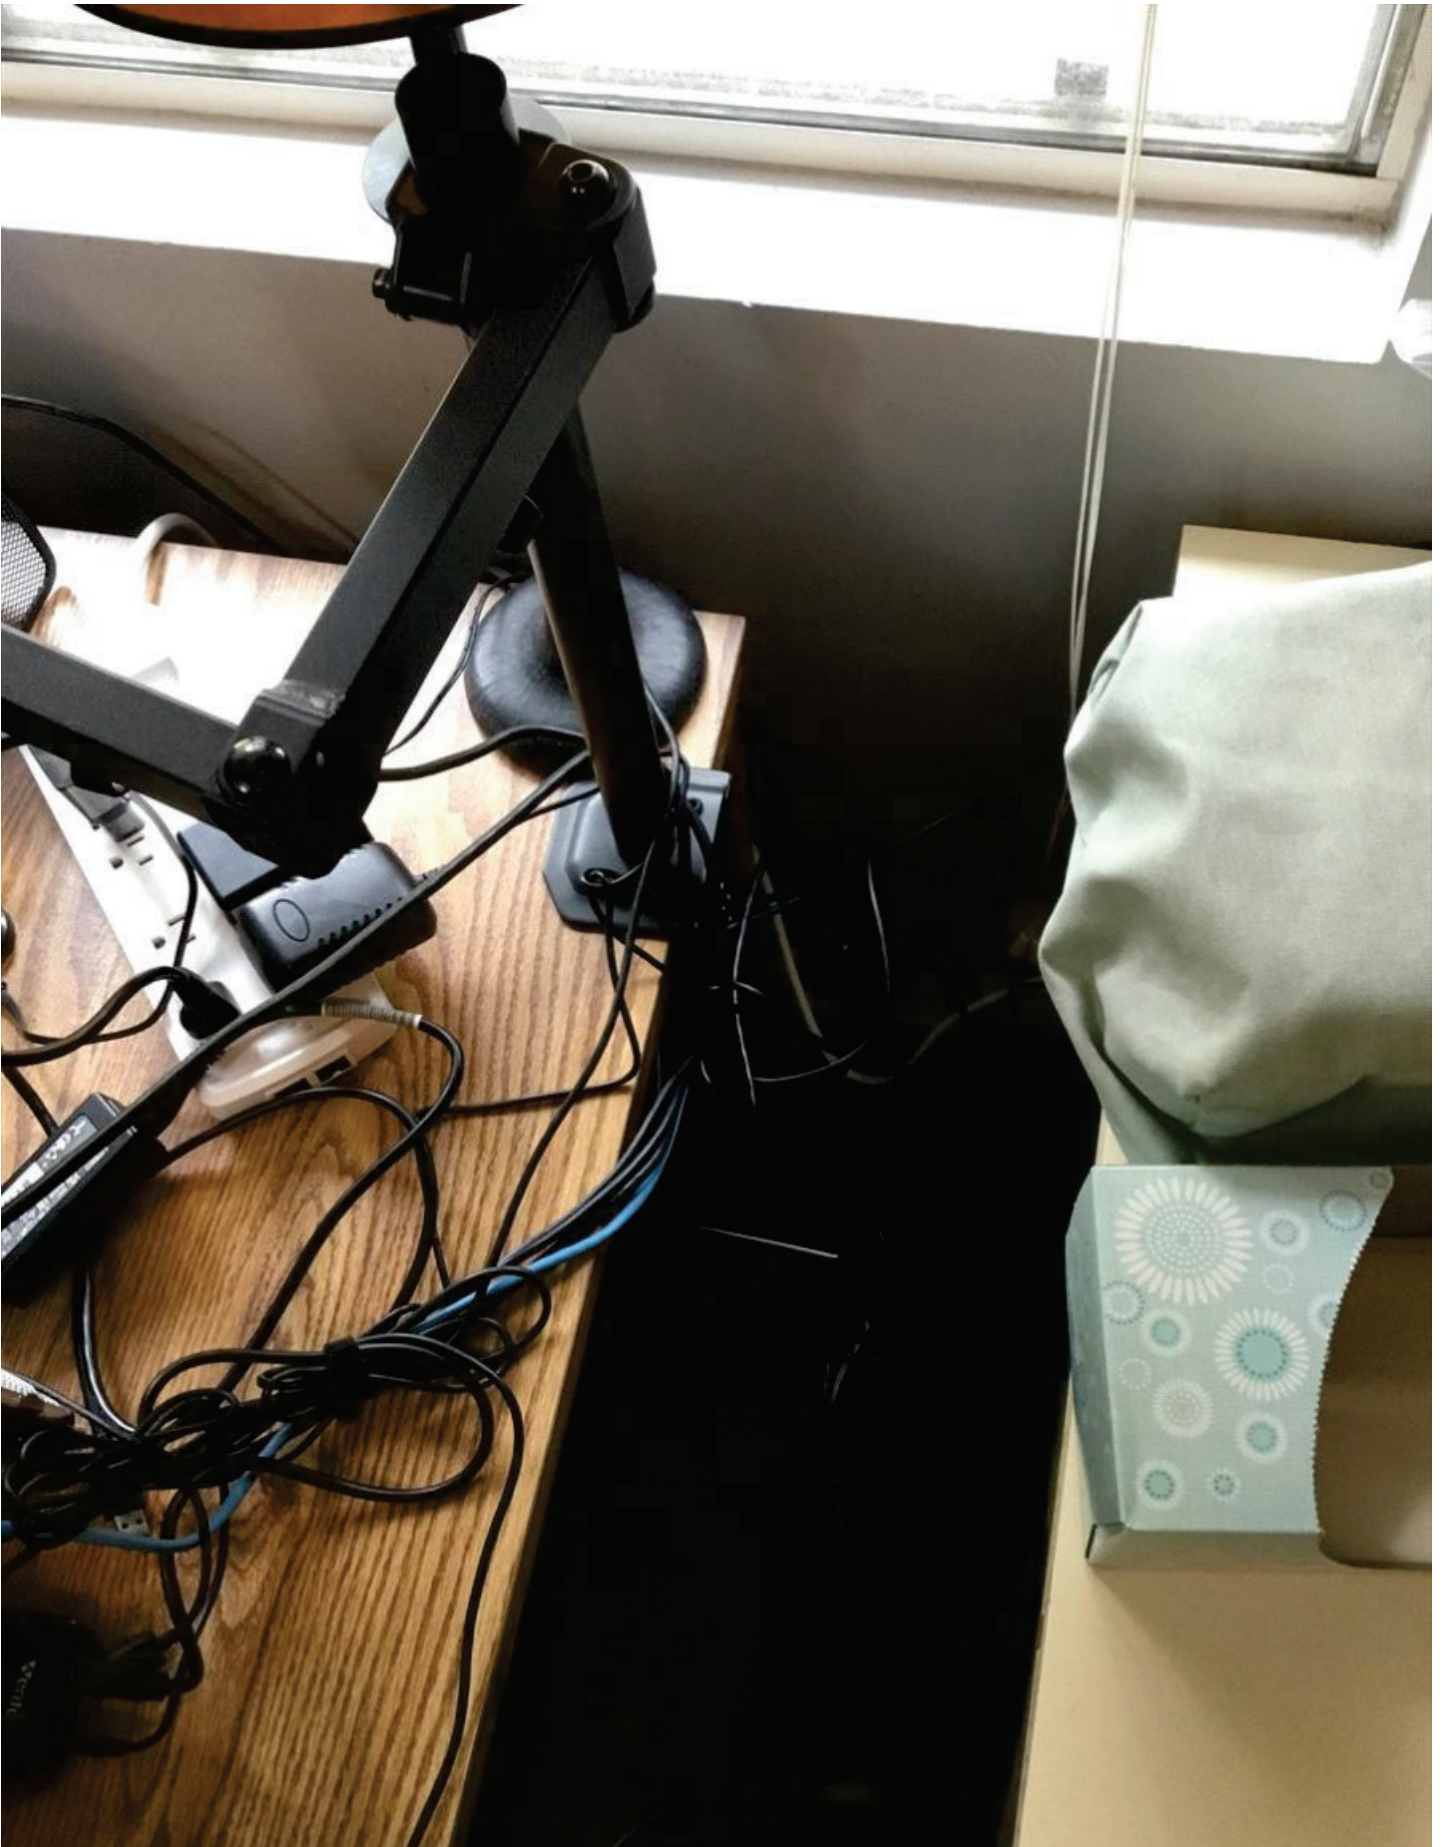
Violation Code: 604.1

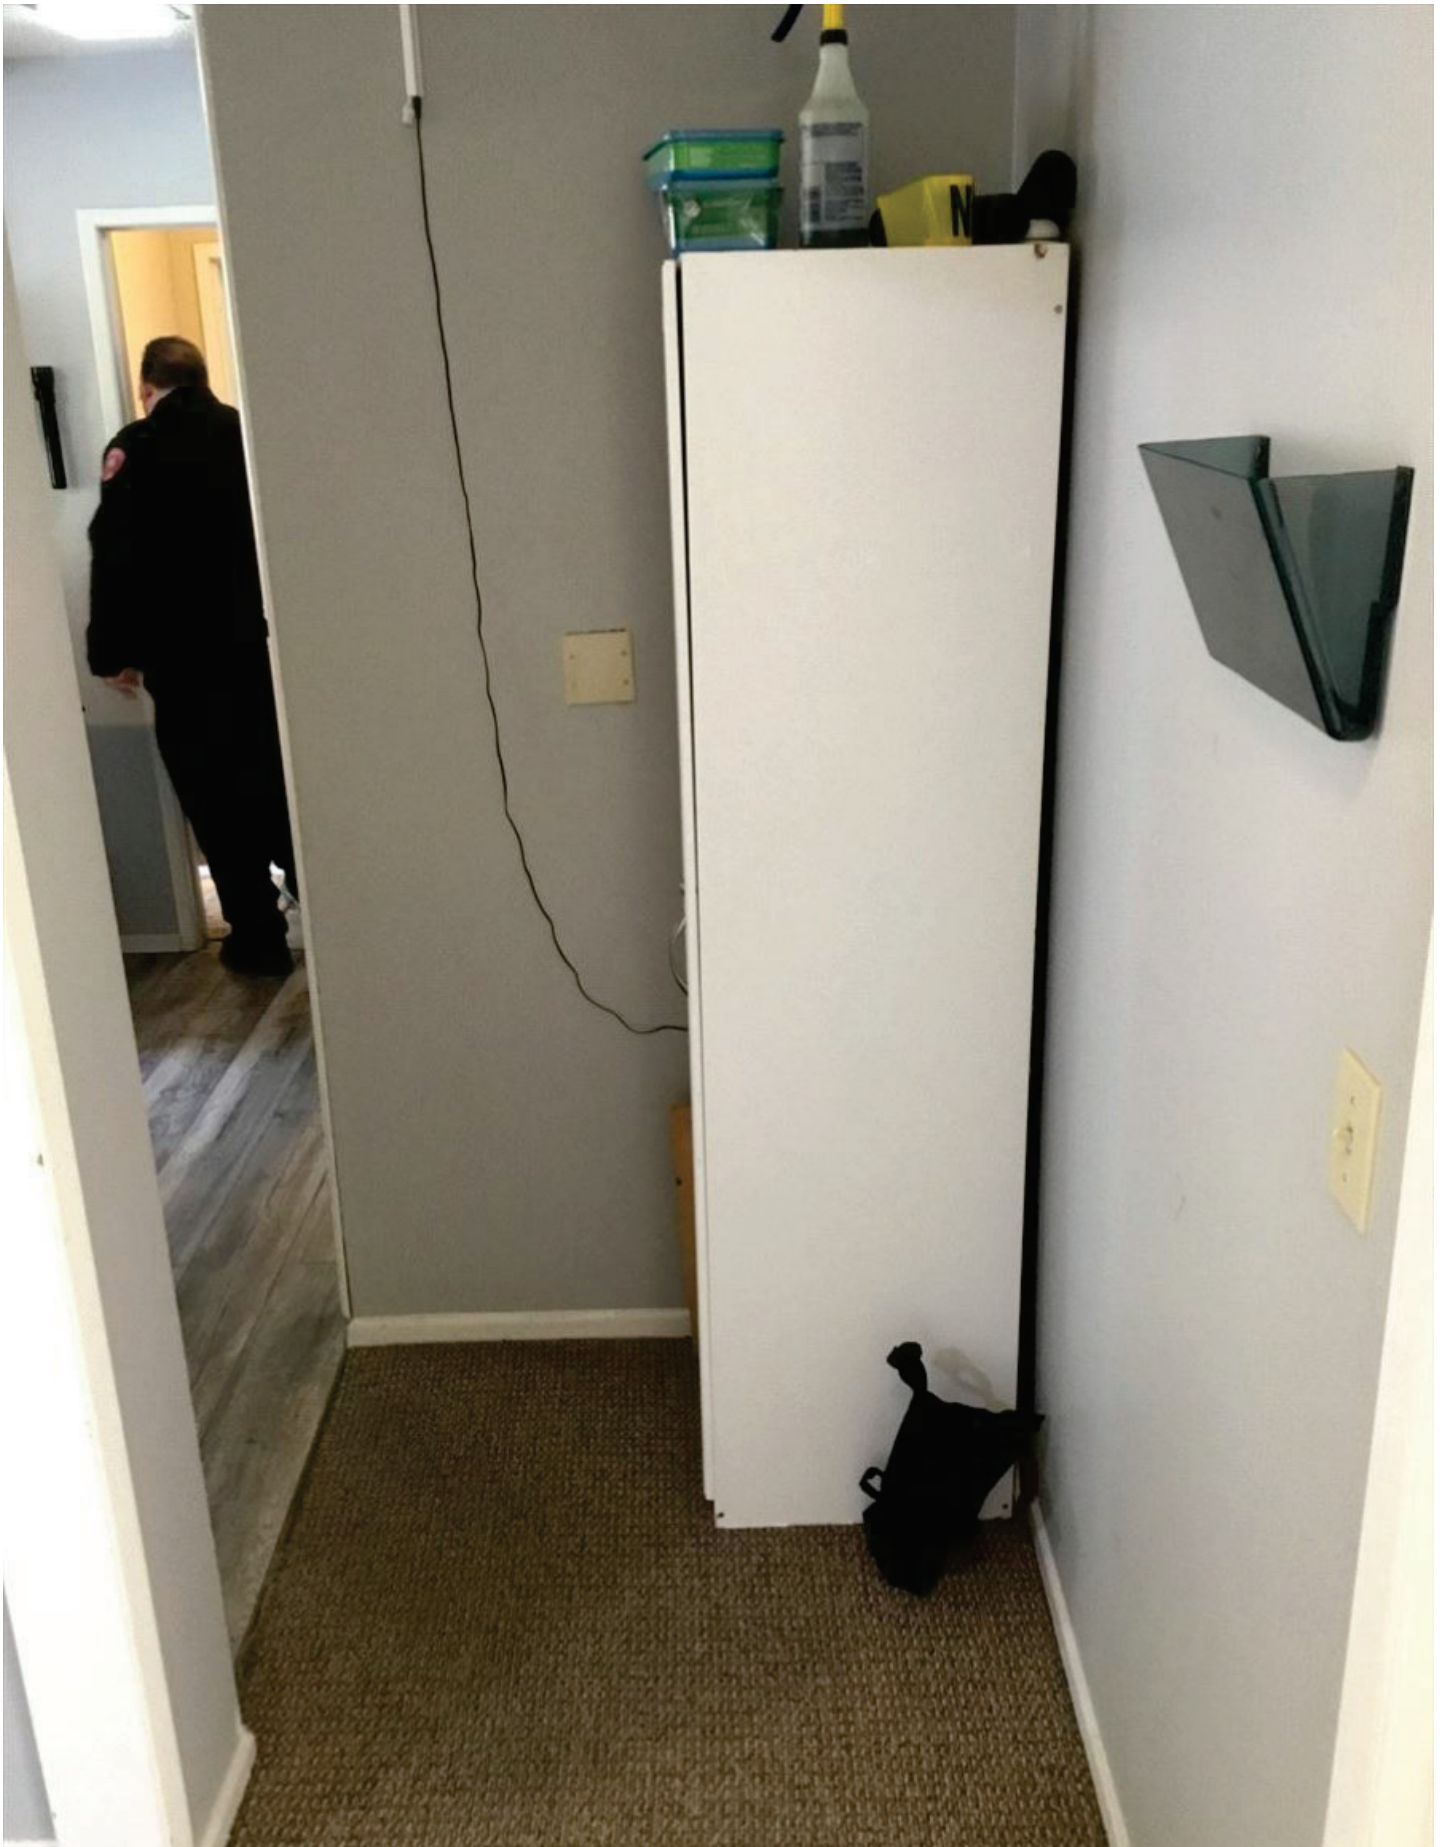
Violation Code: 1020.3
