Cambria Community Healthcare District
2535 Main Street, Cambria, CA

Facility Condition Assessment & Report

**Orry Nottingham PE CAP Inc.
Commissioning Authority & Professional Engineer
November 8, 2021**

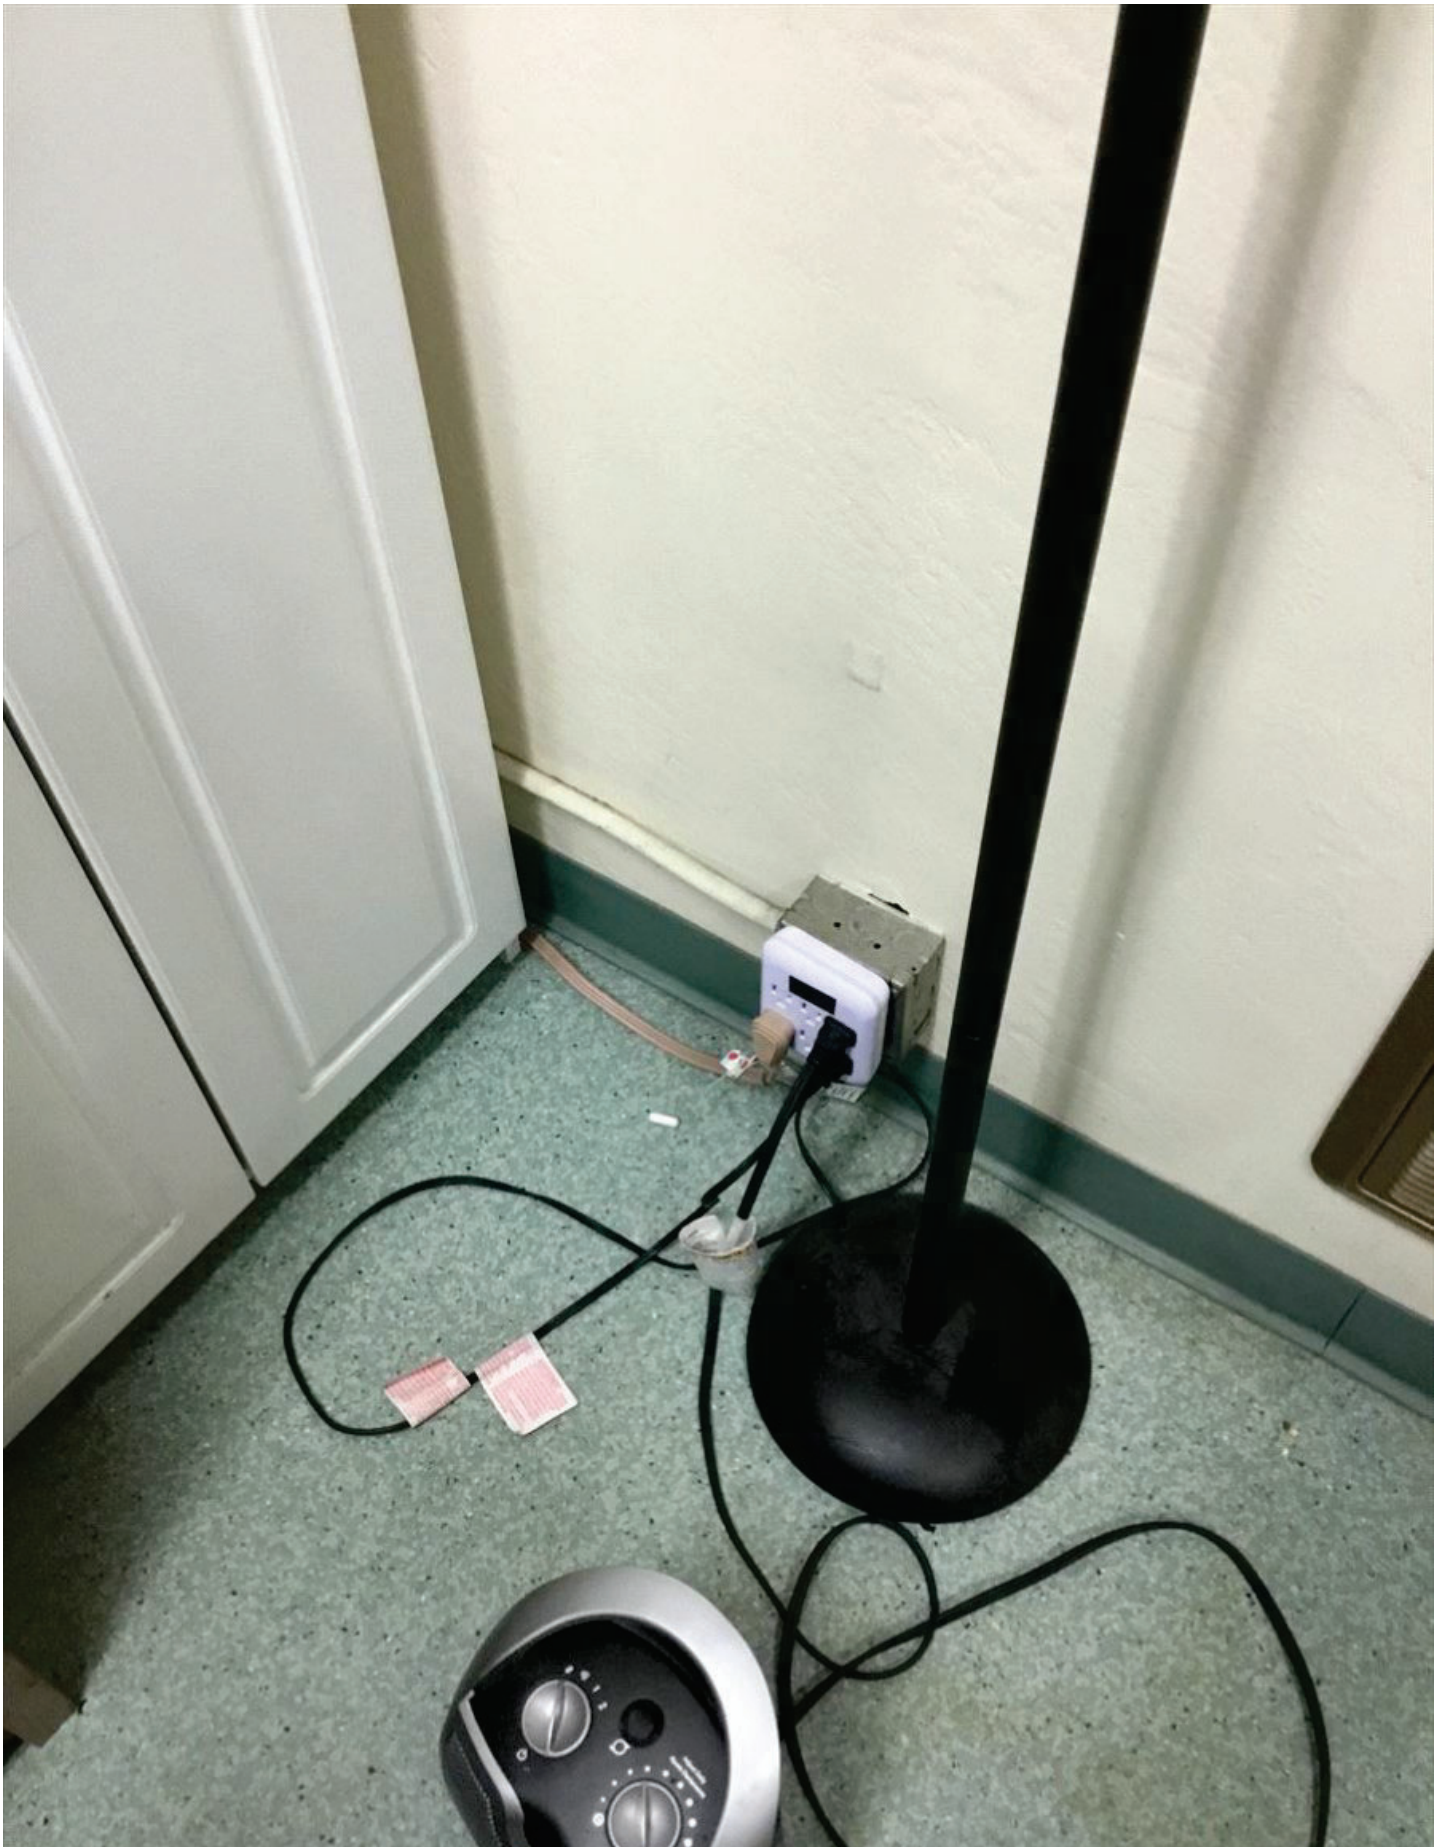
Violation Code: 604.1

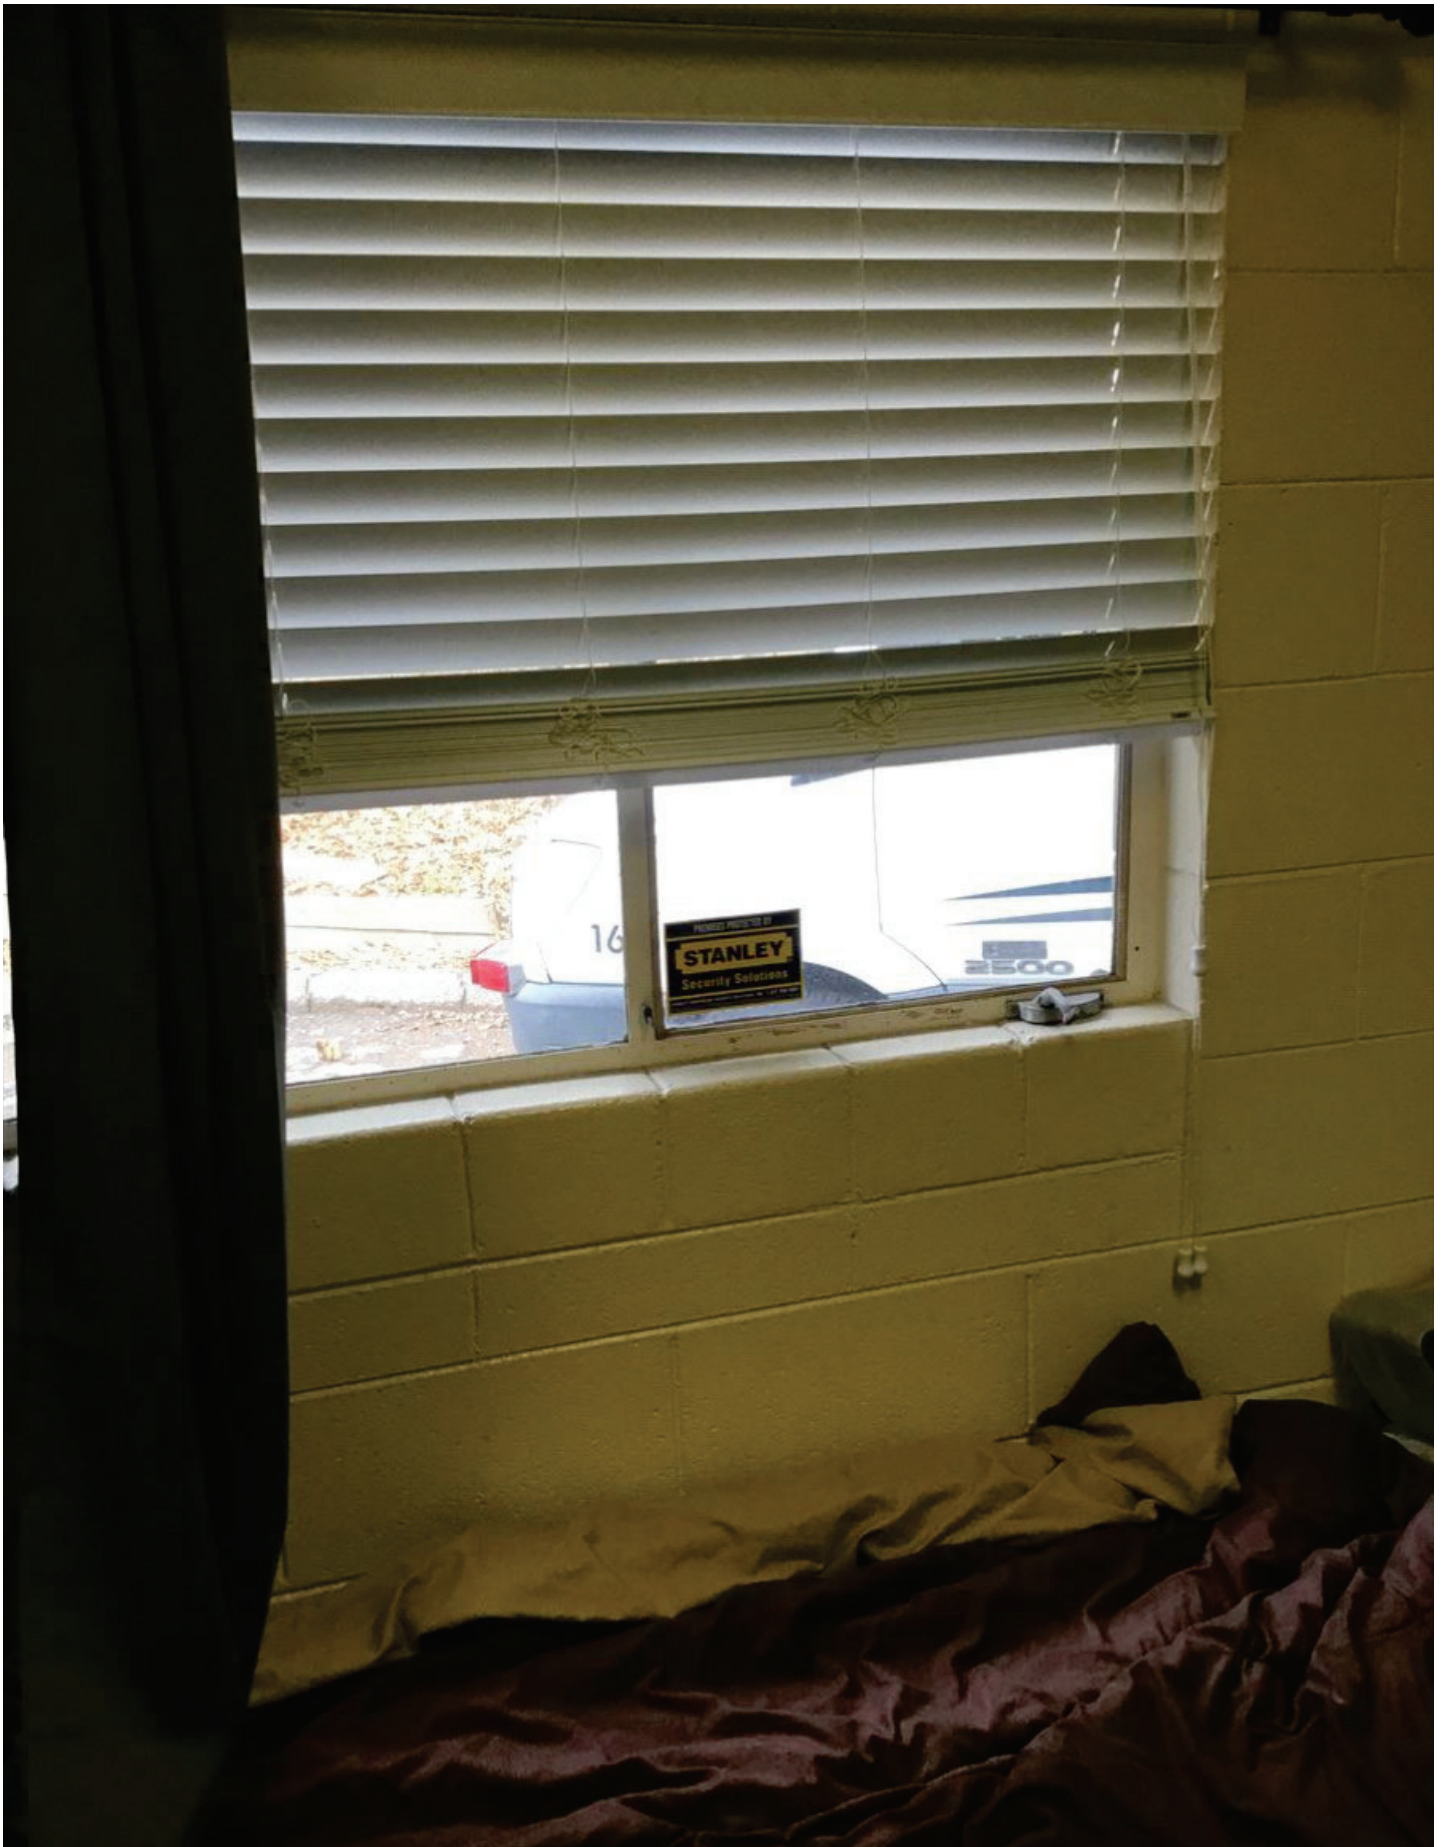
Violation Code: 1006.1

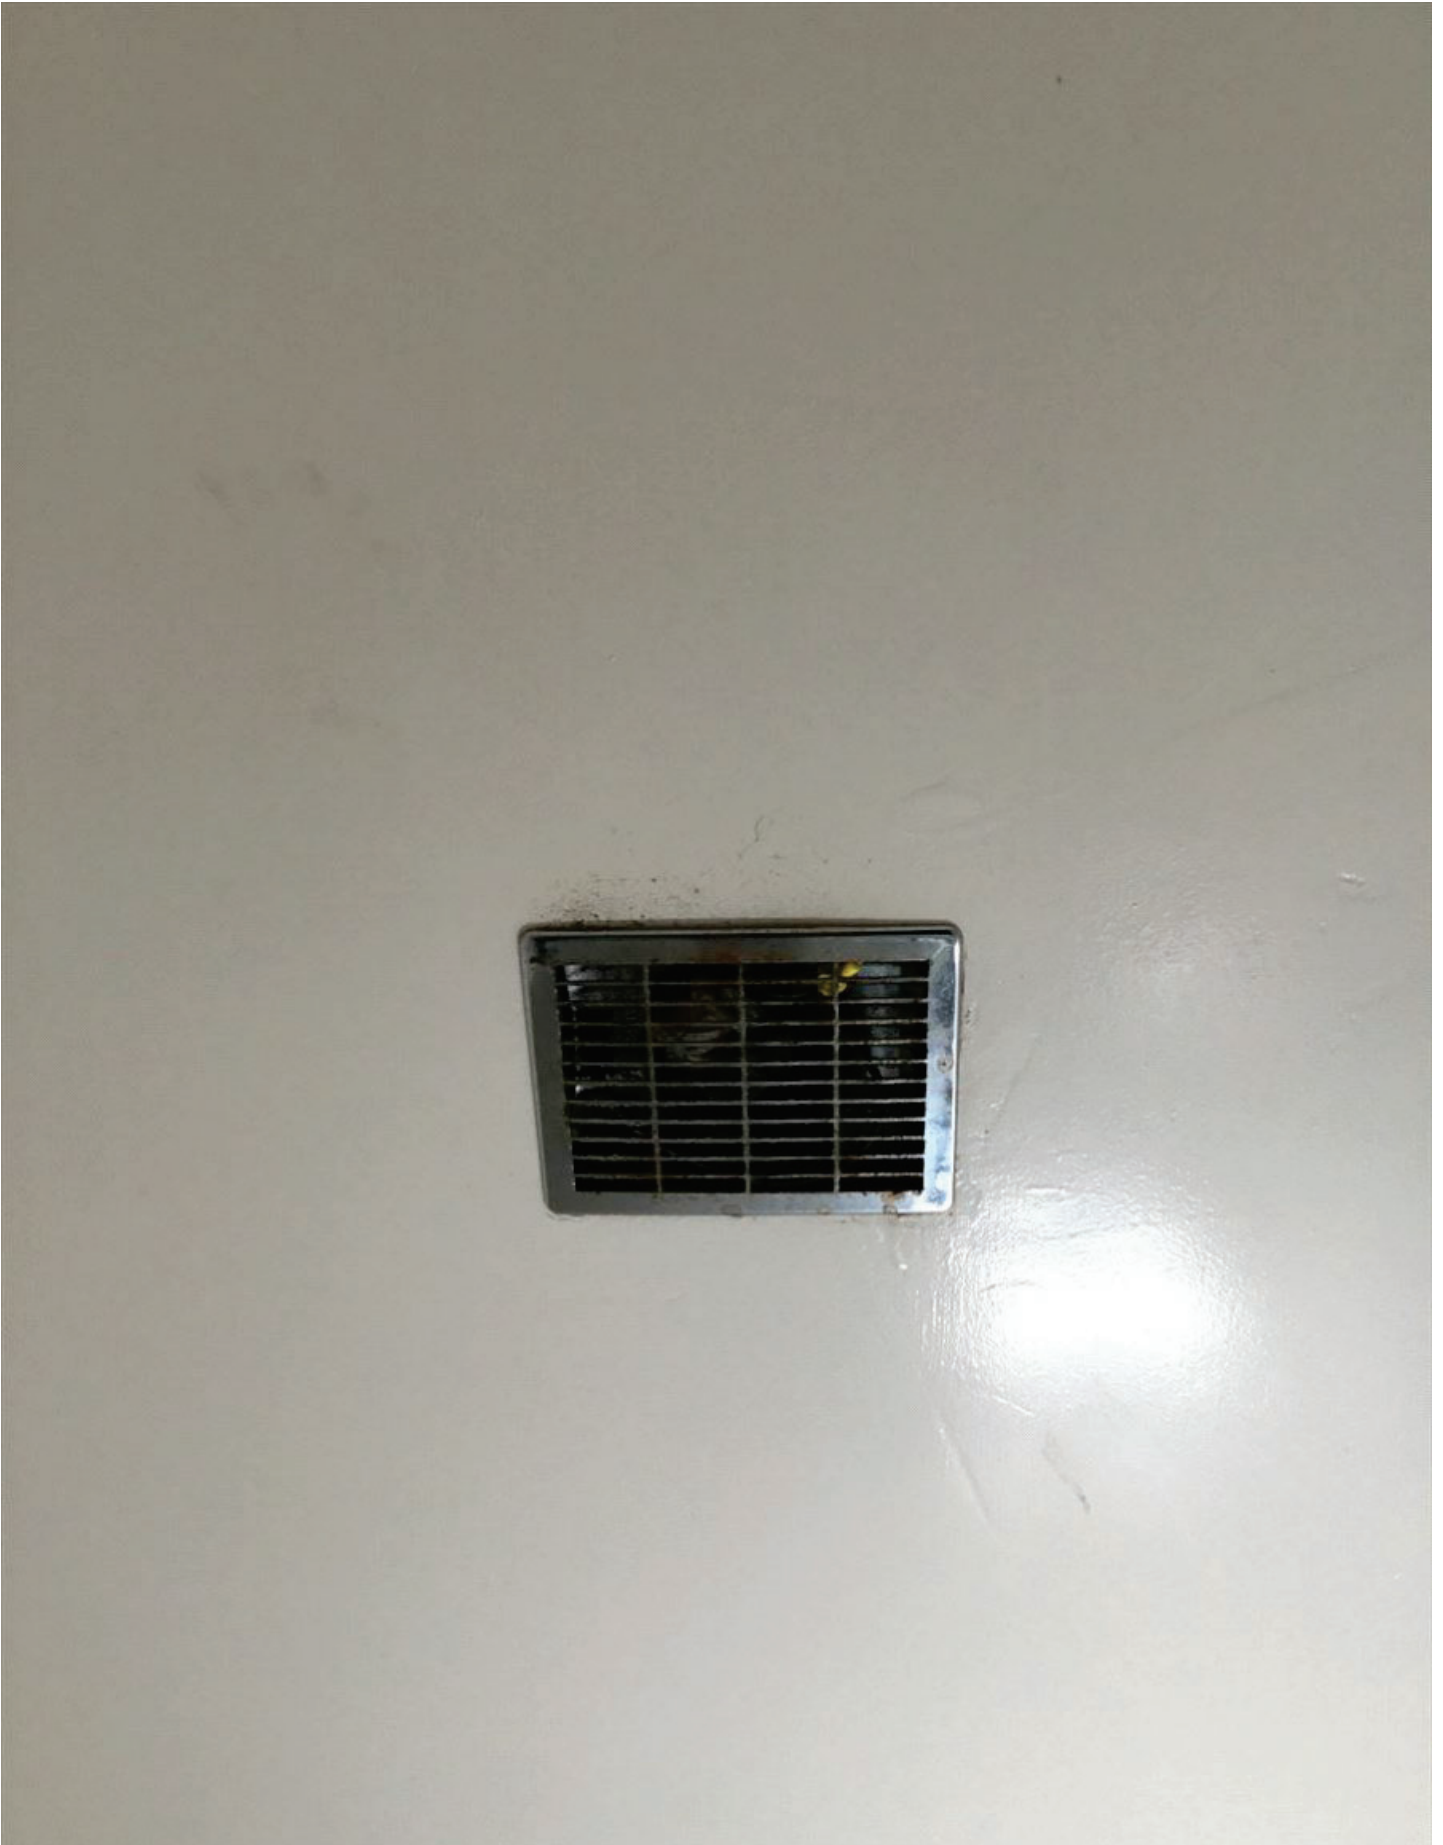
Violation Code: 706.1

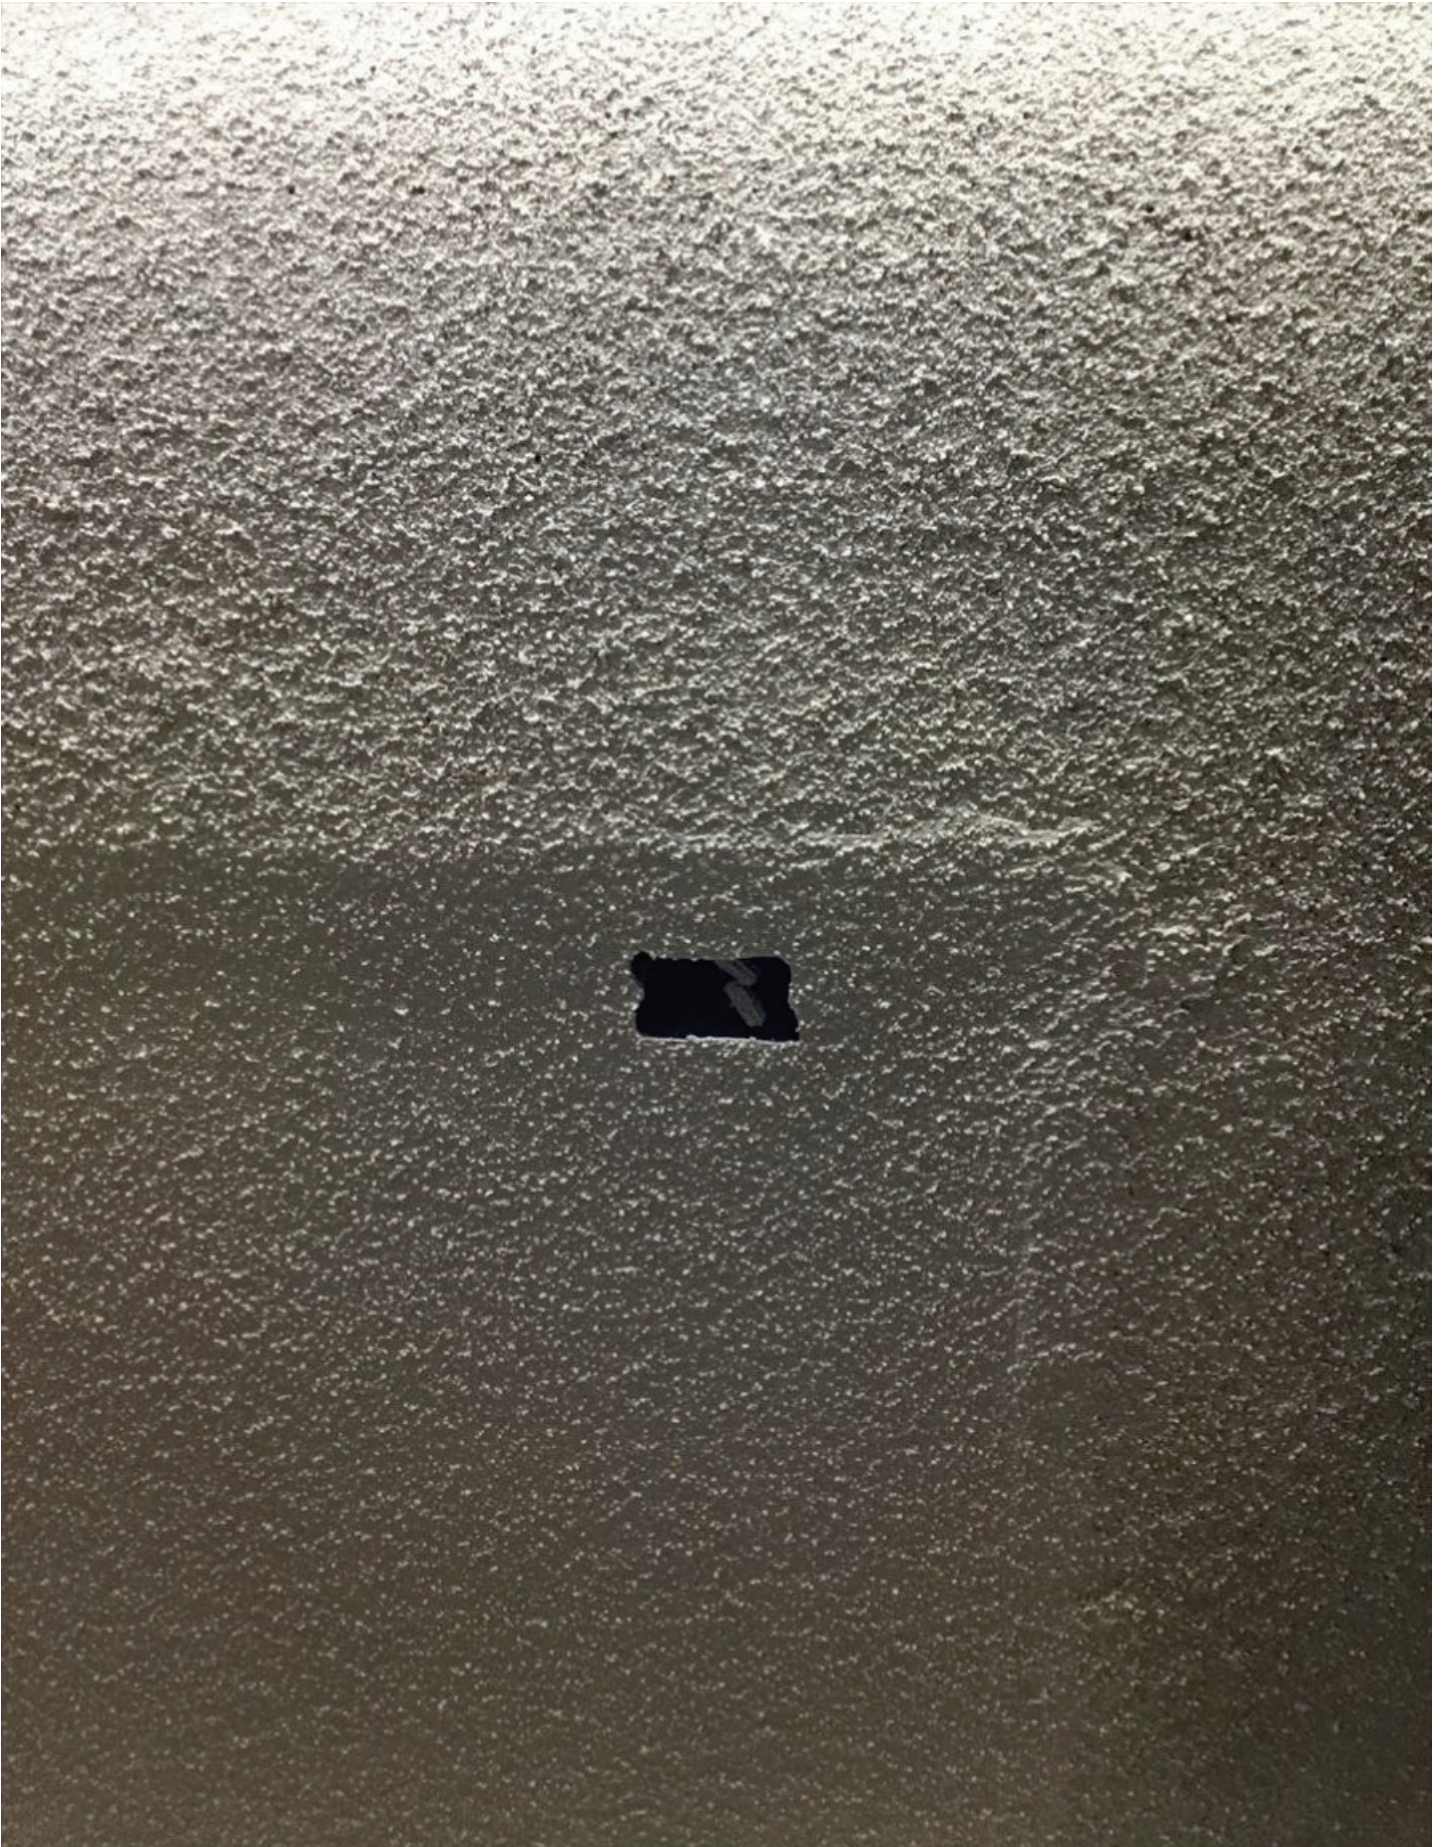
Violation Code: 604.6

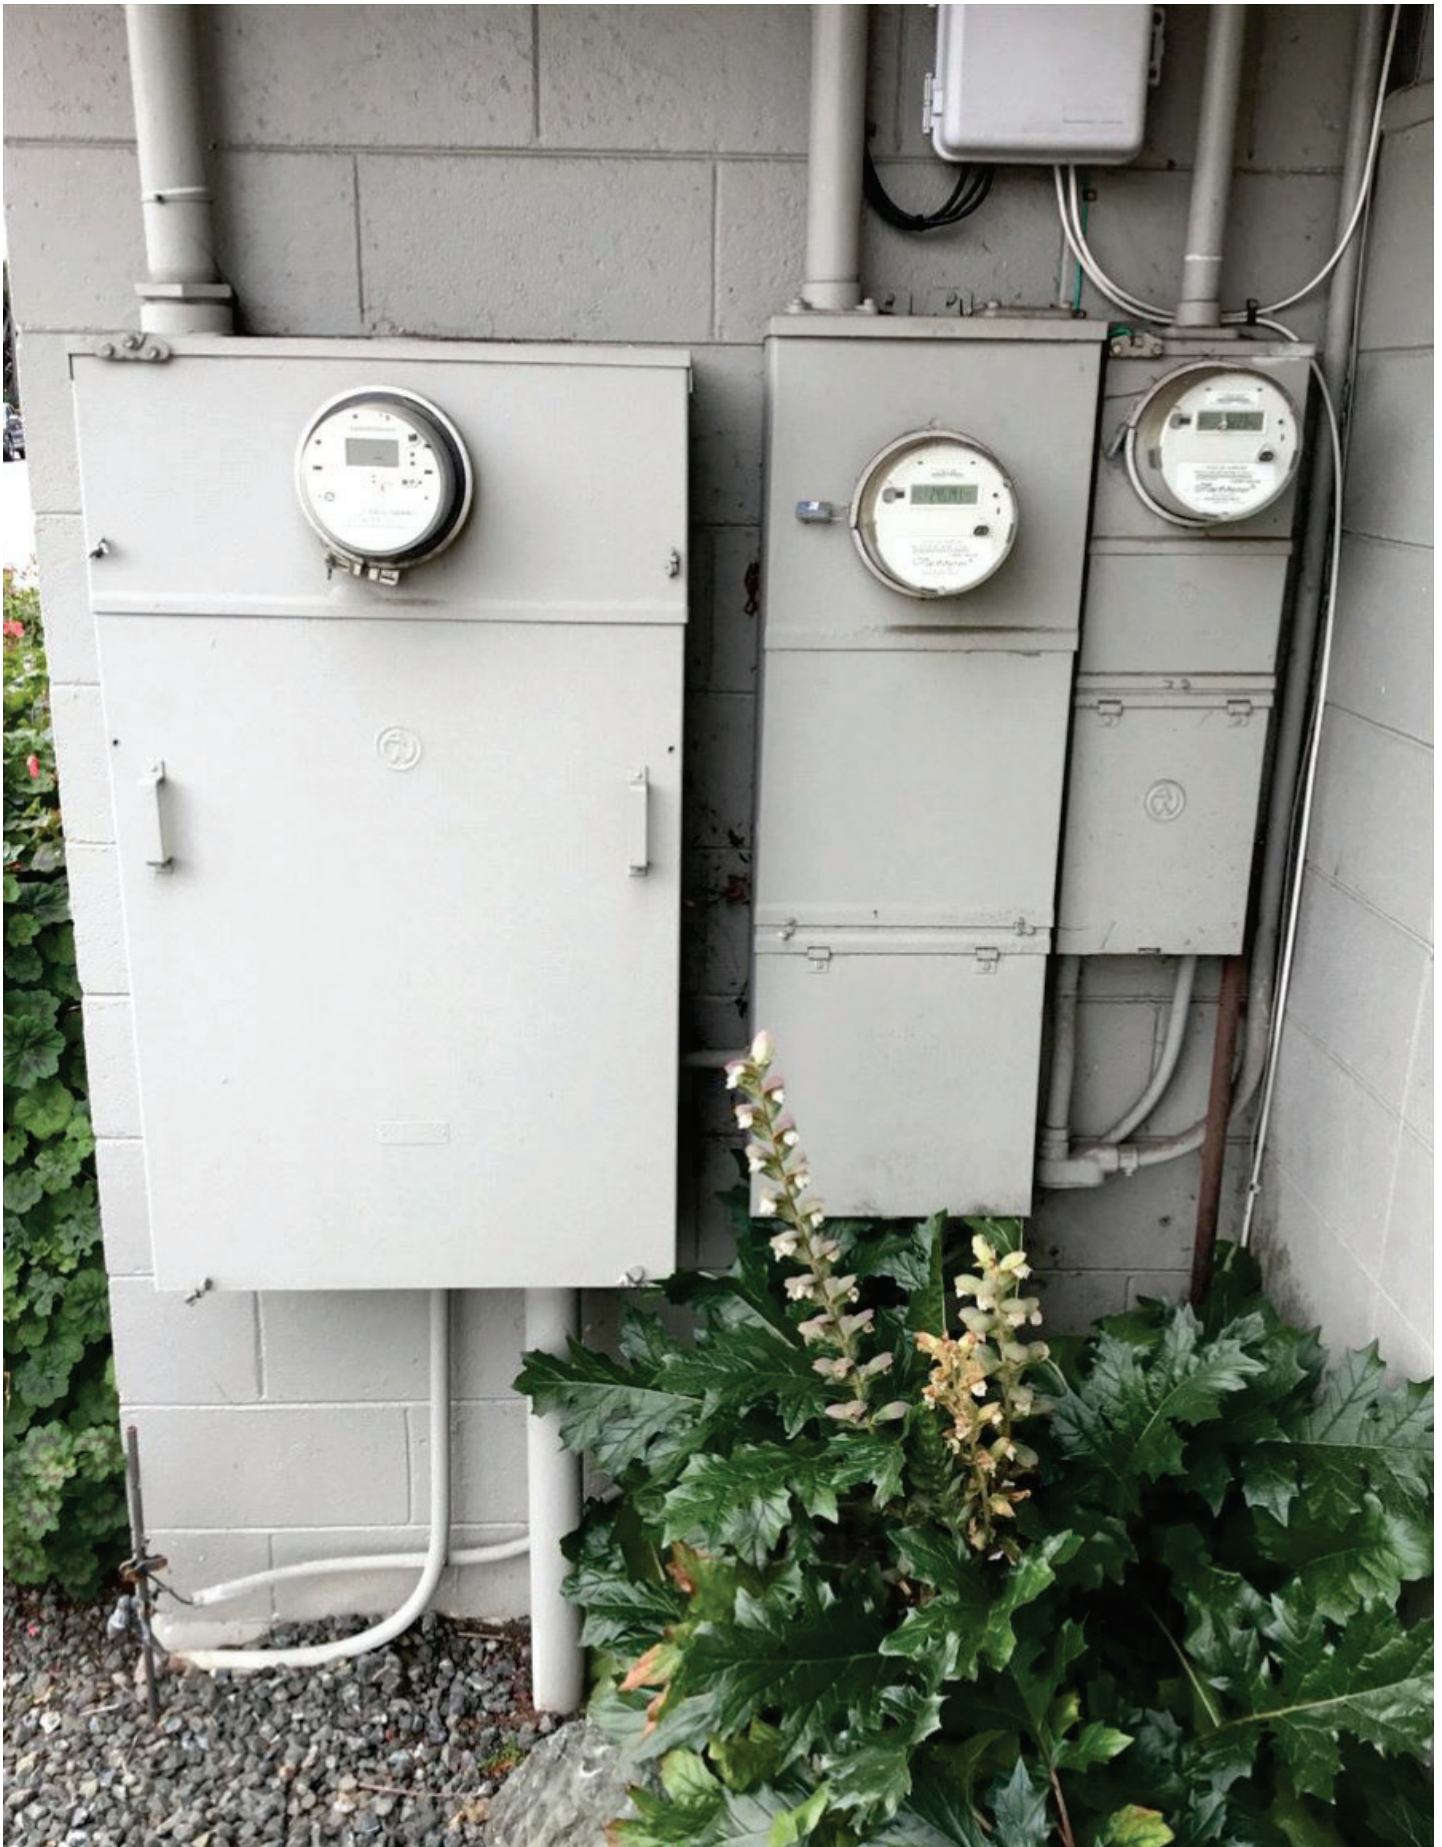
Violation Code: 604.1

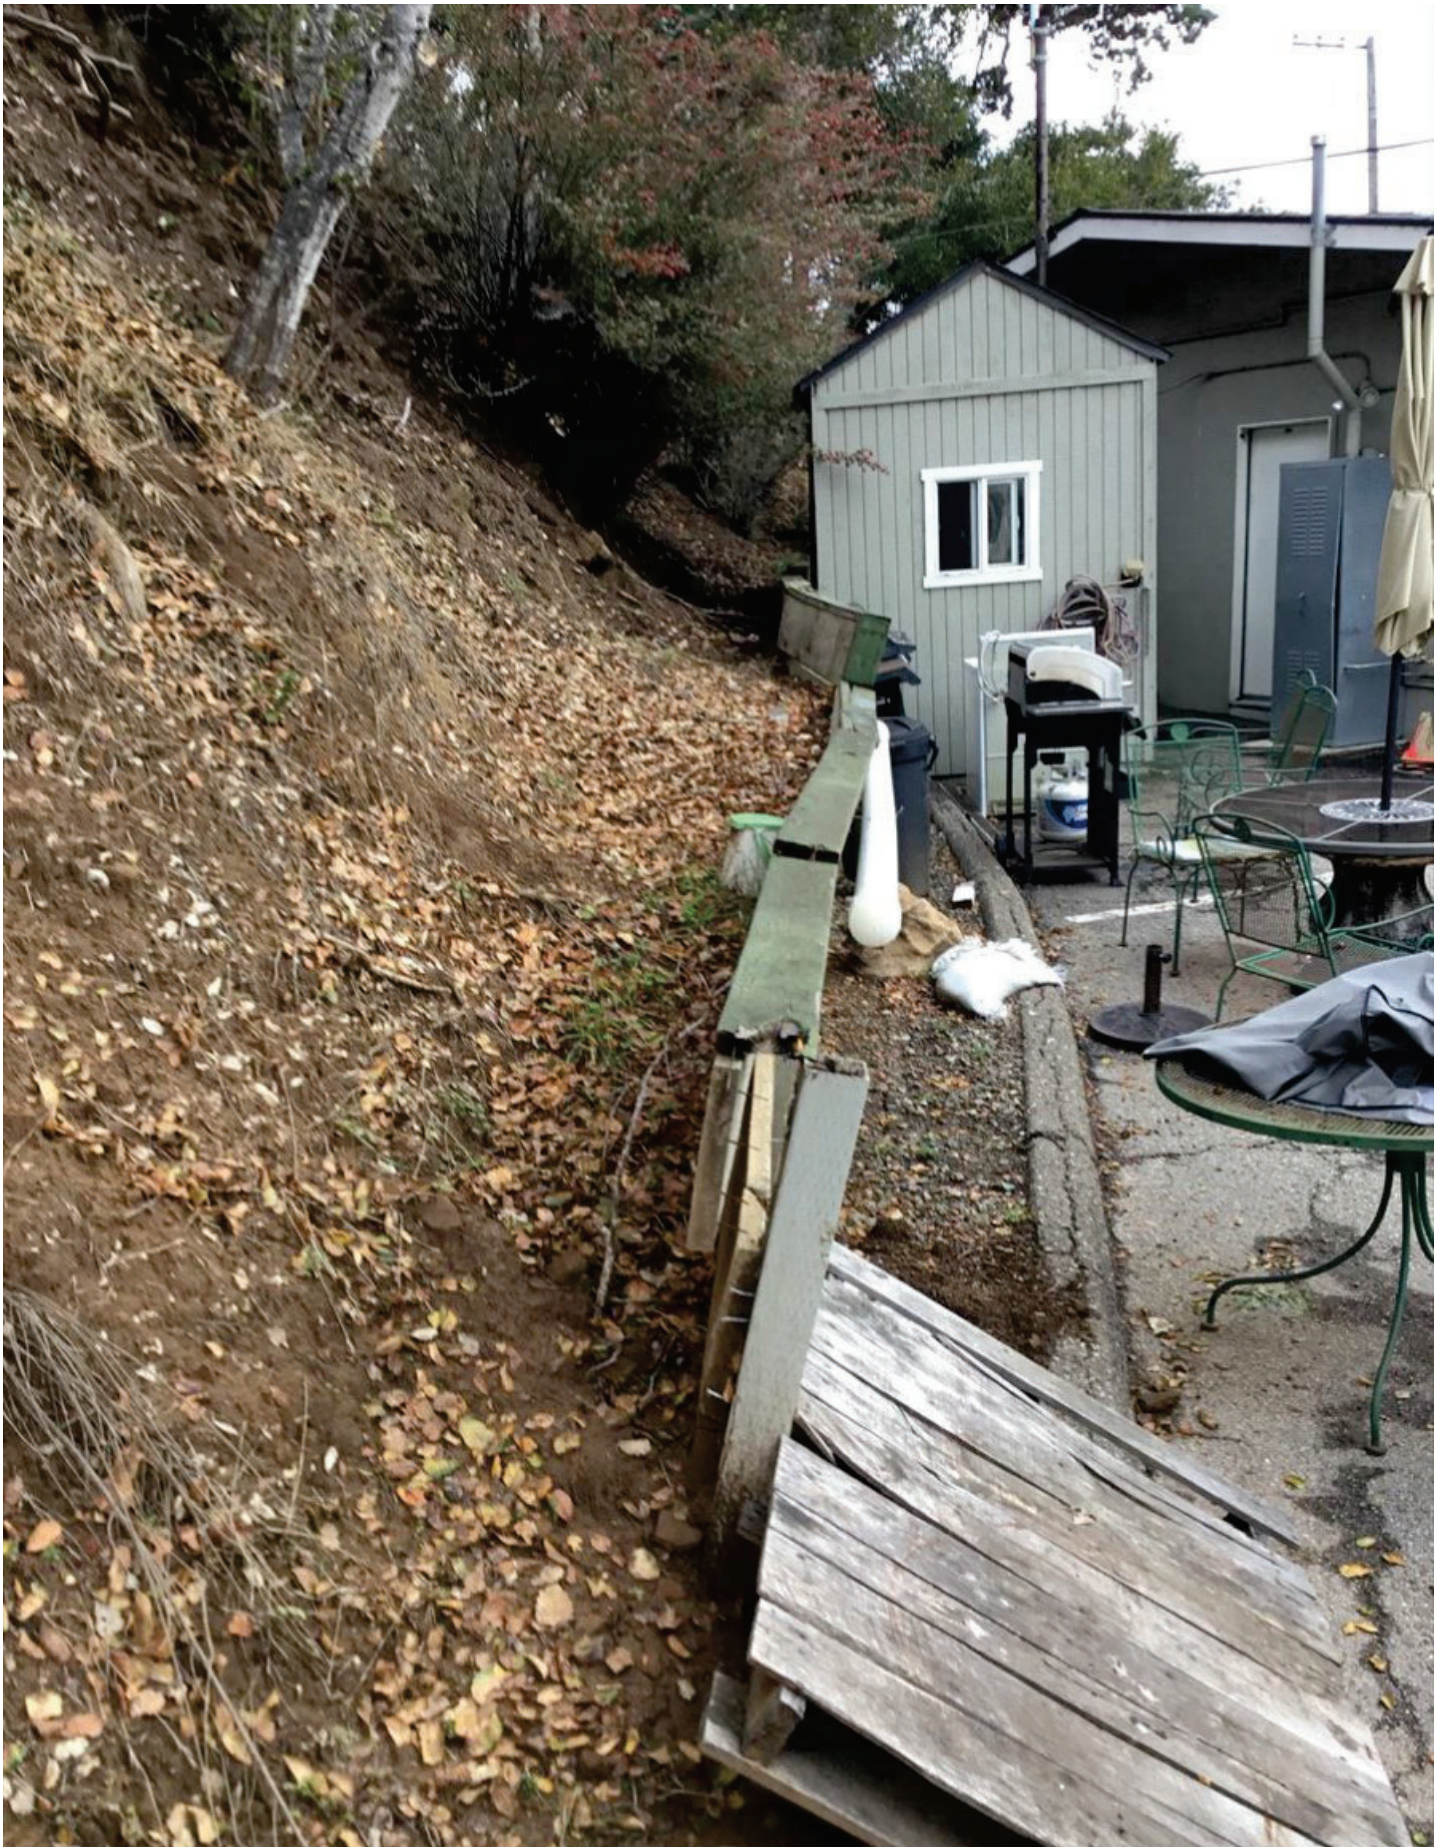
Violation Code: 503.4

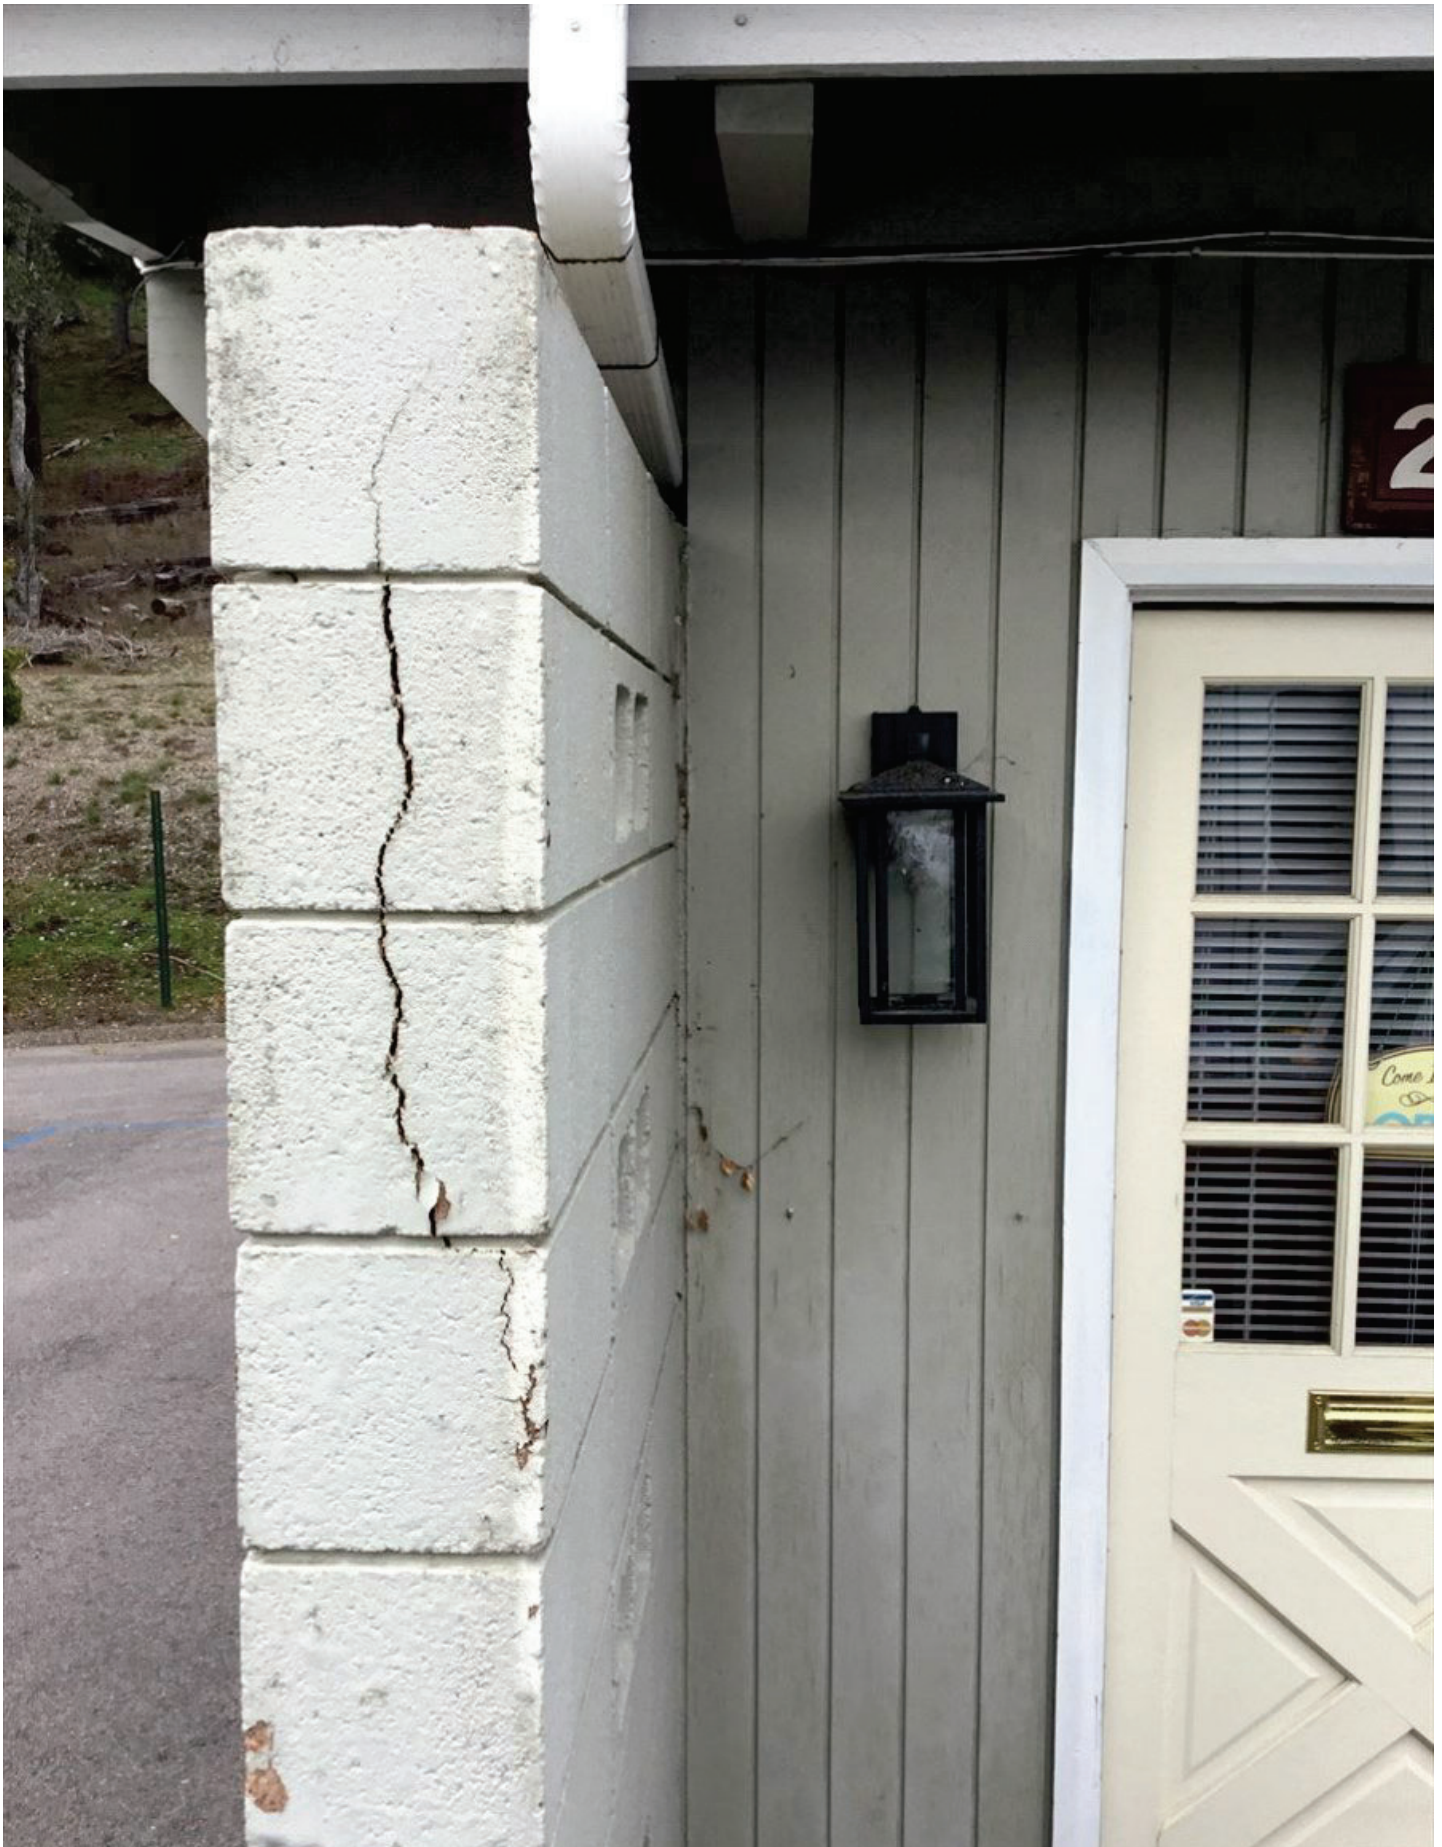
Violation Code: 1020.3
